Trip Report
Seldovia Harbor Improvements
September 10, 2009

This trip report documents the site visit to Seldovia, Alaska to investigate harbor improvements as part of the AKV292 (326049) Seldovia Harbor Improvements Denali Commission project.

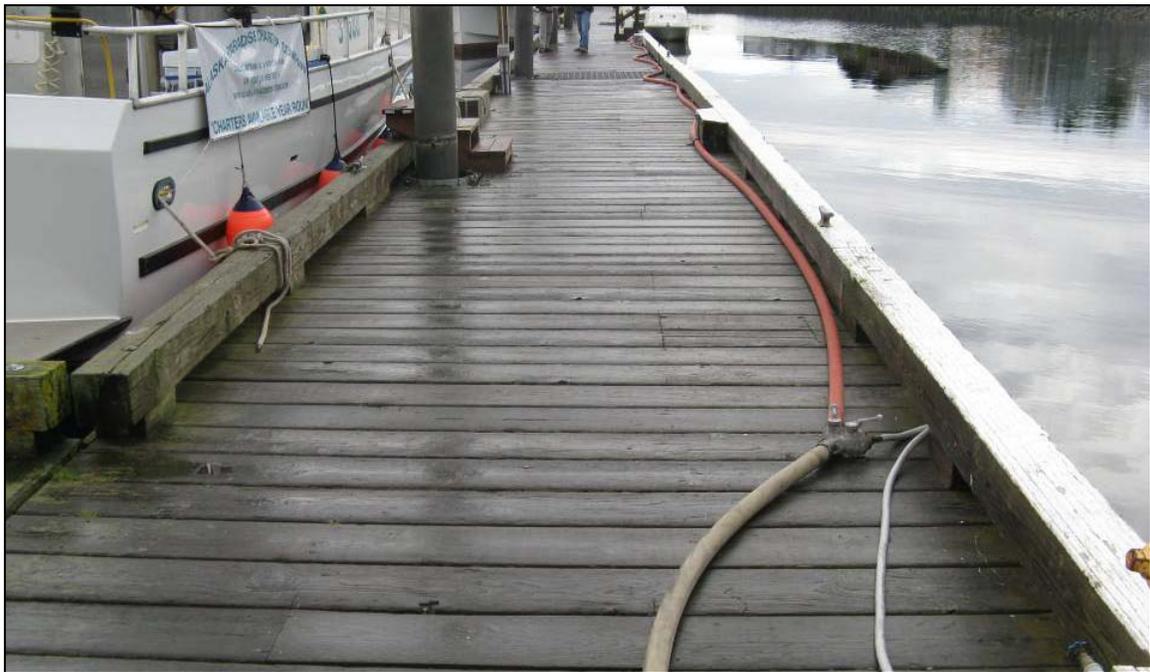
The main run of the dock system has worn decking and bull rails. Both appear solid, but have a fair amount of moss, wear marks, and cracking. In some areas, the bull rail has vegetation growing out of cracks. Towards the north end, the main run appears warped as if the floatation is unevenly distributed. In the same northern area, the dock appears to be significantly undersized for the type of vessels that are moored to it. The main run needs 6, 3-phase meters replaced. The water system being used is a series of fire hoses with connections to previously installed water spigots. The city reports they are using this system now because the older system was breaking daily and had become a maintenance burden. The city reports that if the fire hose system were adjusted for easy installation and safe placement, they would be very satisfied. To the south along the main run the decking and bull rail show similar signs of wear as the north end. There is also warping of the main run dock showing an uneven distribution of floatation.

Figure 3 – Main Run Show Decking Wear and Hose Watering System

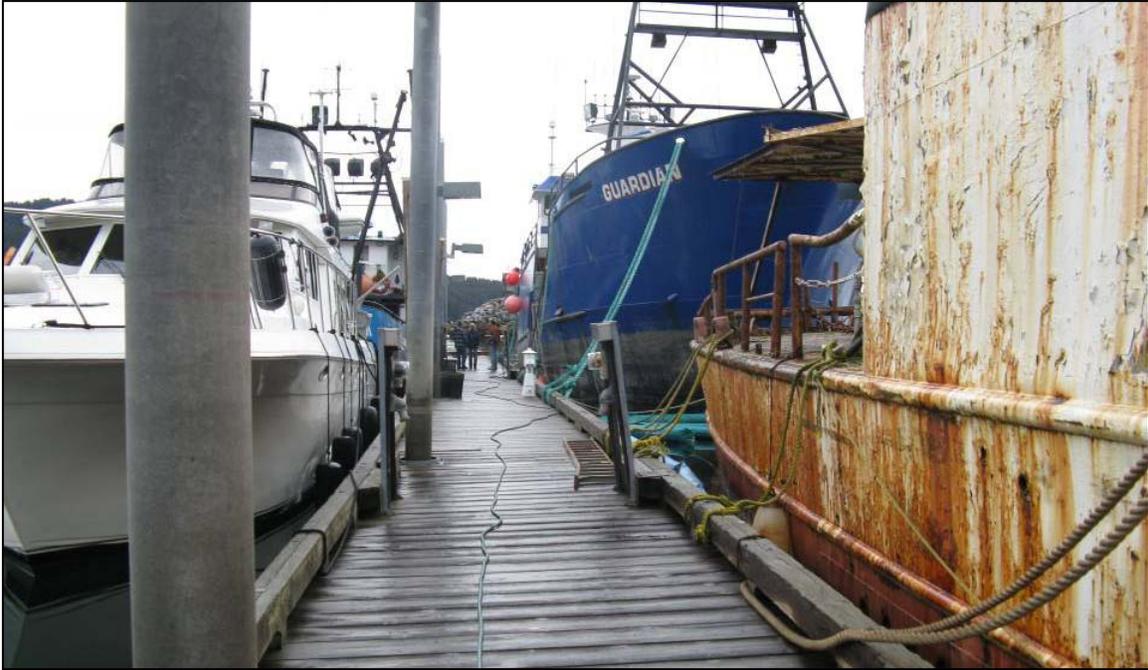
Figure 4 - Main Run Warping

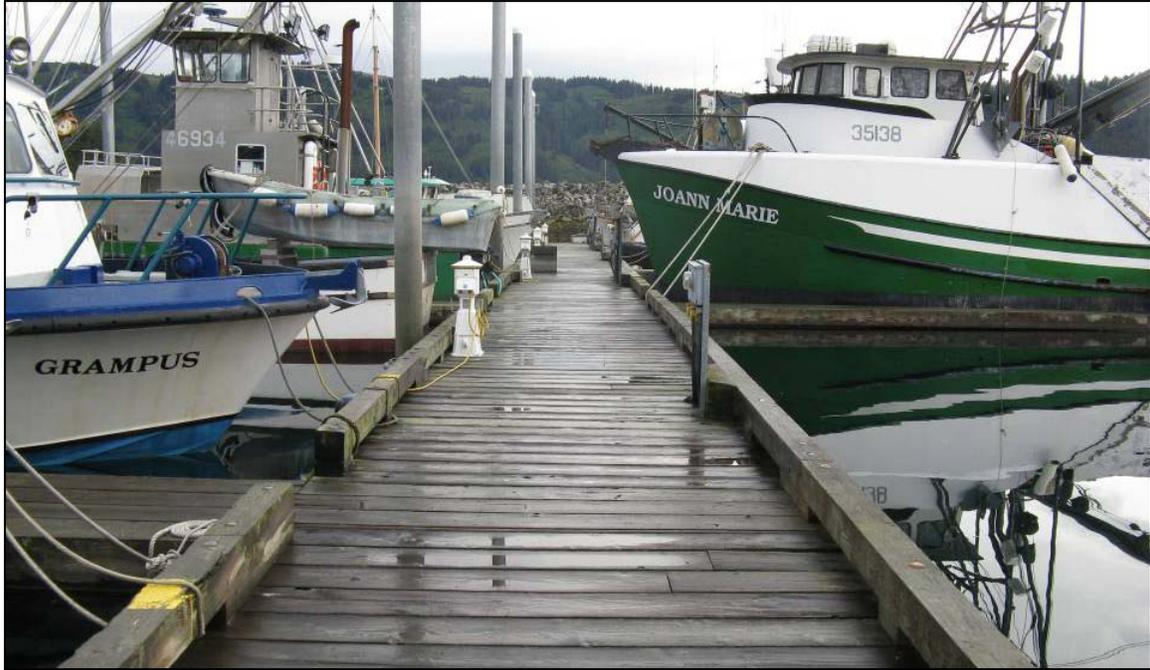
A Dock has worn decking and bull rails. Both appear solid, but have a fair amount of moss, wear marks, and cracking. In some areas, the bull rail has vegetation growing out of cracks. The finger piers are fastened using a pin system leaving the fingers to not be stable. The slippery nature of the decking in combination with the finger pier instability provides for a potential safety hazard. The float is in need of 3 light standards and 3 30 Amp service pillars. There are 2 groups of piling (three piling each) that are not utilized and can be removed.

Figure 5 - A Dock Showing Decking and Bull Rail Condition

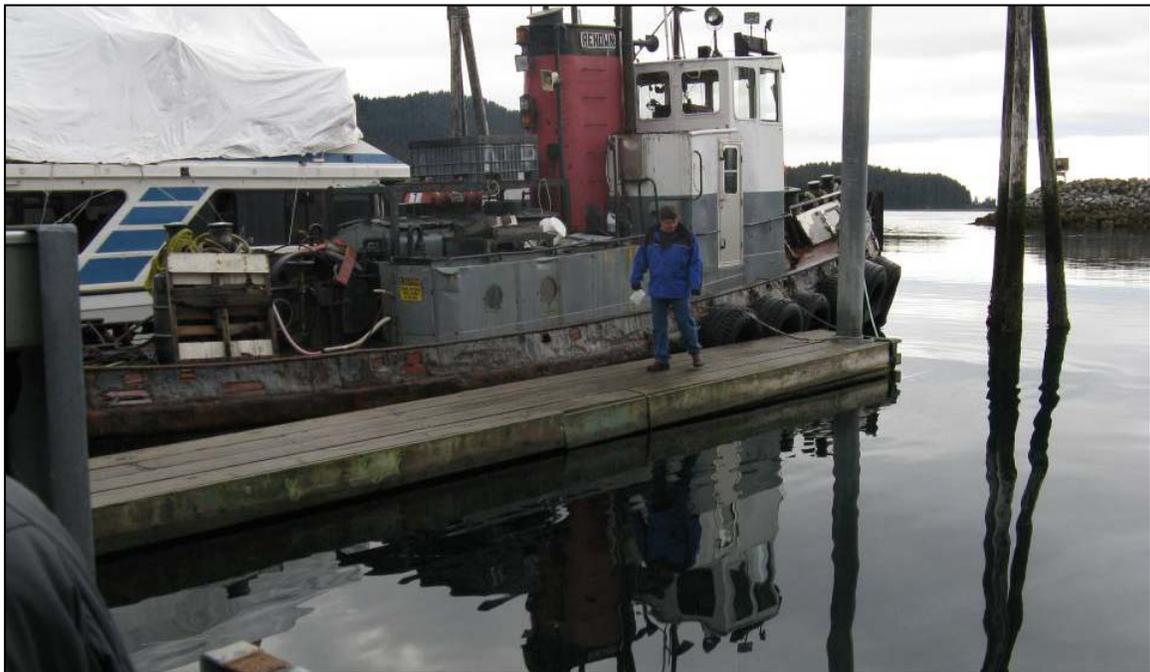
Figure 6 - A Dock Typical Finger Pier

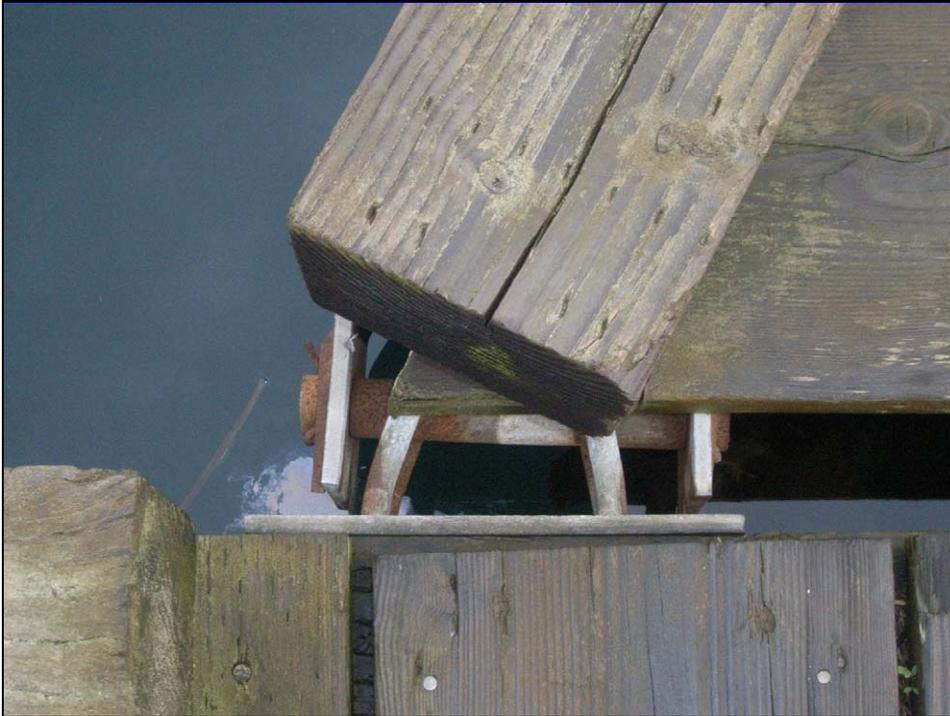
Figure 7 - Typical Finger Pier Pin Connection

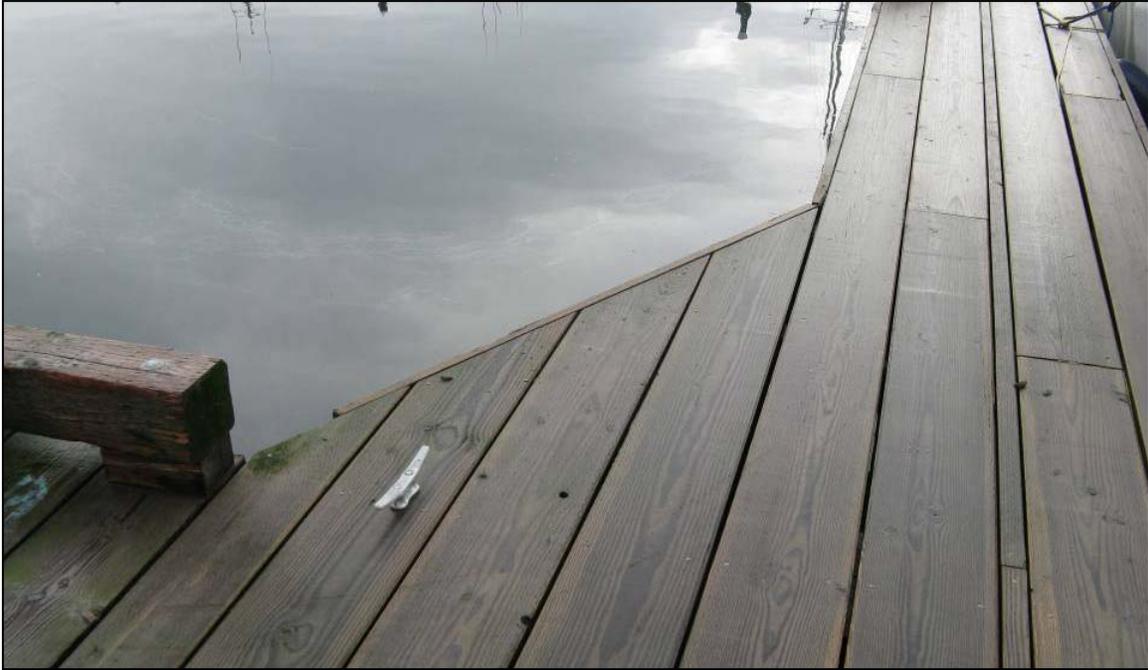
B Dock has worn decking and bull rails. Both appear solid, but have a fair amount of moss, wear marks, and cracking. Some sections of B Dock have been replaced. The finger piers have a solid connection that is integrated into the main run of B Dock. This provides a stable finger pier. The city commented the fillet that is integrated into the finger pier connection does not allow vessels to back into their slips. Two piles that were to be installed are missing. Two wooden piles need to be removed. The electrical system on B Dock is satisfactory.

Figure 8 - B Dock Finger Pier

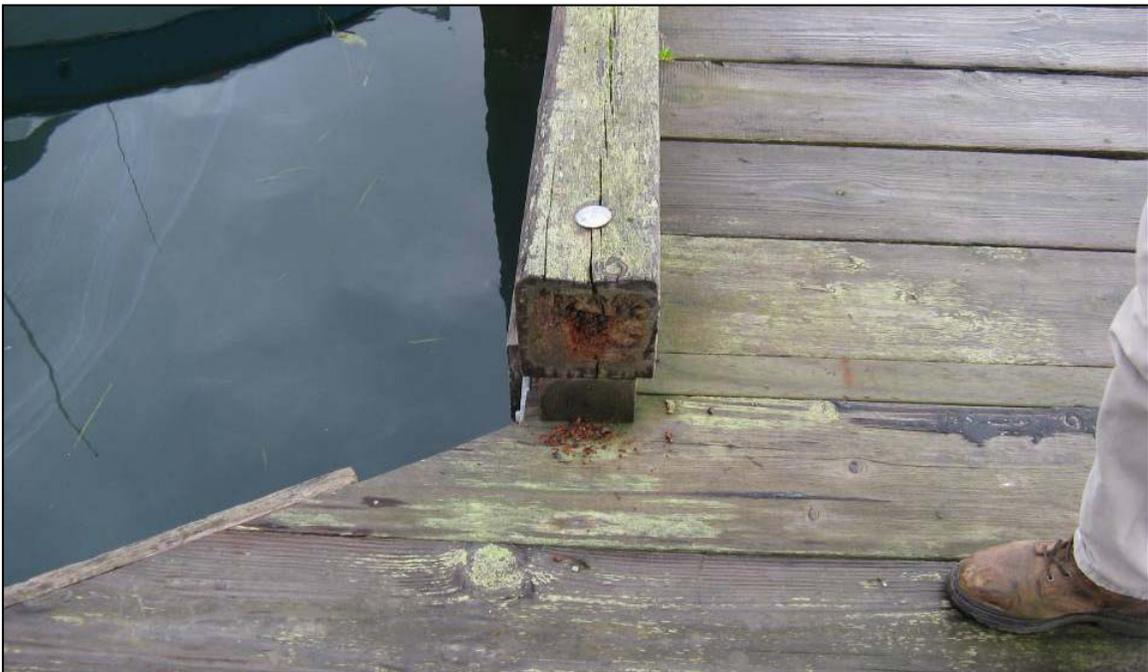
Figure 9 - B Dock Bull Rail Rot

With regards to the wood decking and bull rails a brief inspection of the harbor facilities shows that some of the bull rails show signs of rotting and a smaller percentage of the decking is showing signs of rotting. A rough estimated 20-30% of the bull rails and decking could use replacement including the airplane float that is weathered and in need of replacement. The under structure appeared to be in fair condition with no areas of rot noted in this brief site visit. We might consider developing a few options to deal with the decking and bull rails. Areas of flotation under the floats had been recently repaired; one obvious area along the main run may require additional replacement/repair of the existing flotation system.

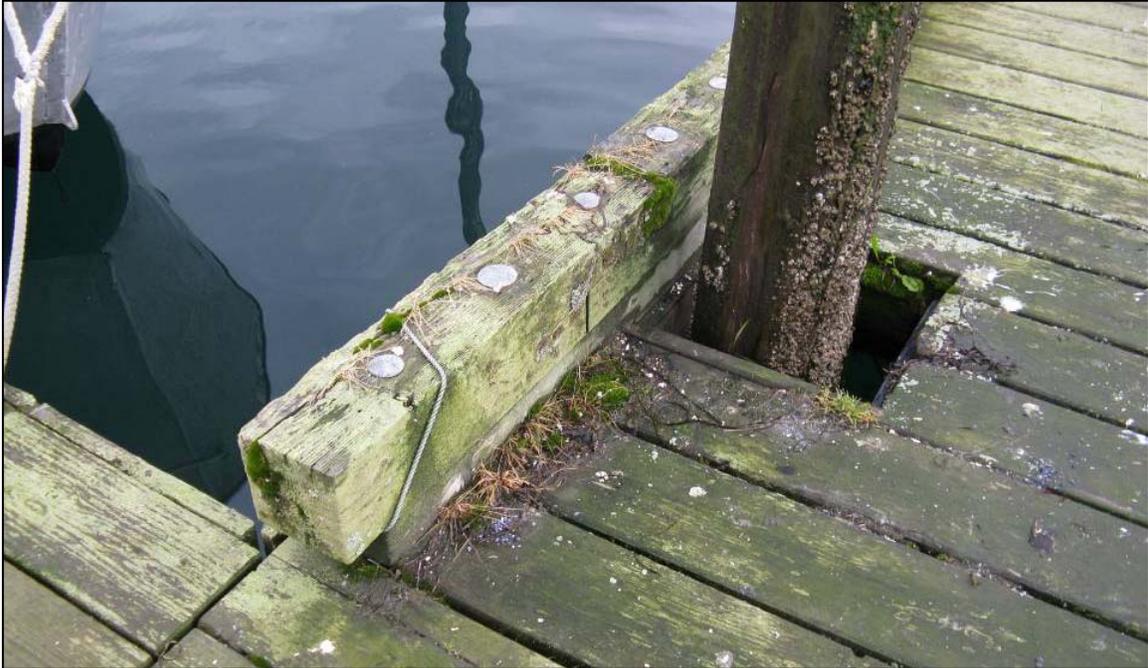
C Dock has worn decking and bull rails. Both appear solid, but have a fair amount of moss, wear marks, and cracking. In some areas, the bull rail has vegetation growing out of cracks. The finger piers are fastened using a pin system leaving the fingers to not be stable. The slippery nature of the decking in combination with the finger pier instability

provides for a potential safety hazard. 3 of the new metal piles are missing. 21 wood piles need to be removed. The city reports that vessels cannot pass the end of C Dock at low tide when a boat is moored at the end because the water is too shallow.

Figure 10 - C Dock Typical Deck and Bull Rail

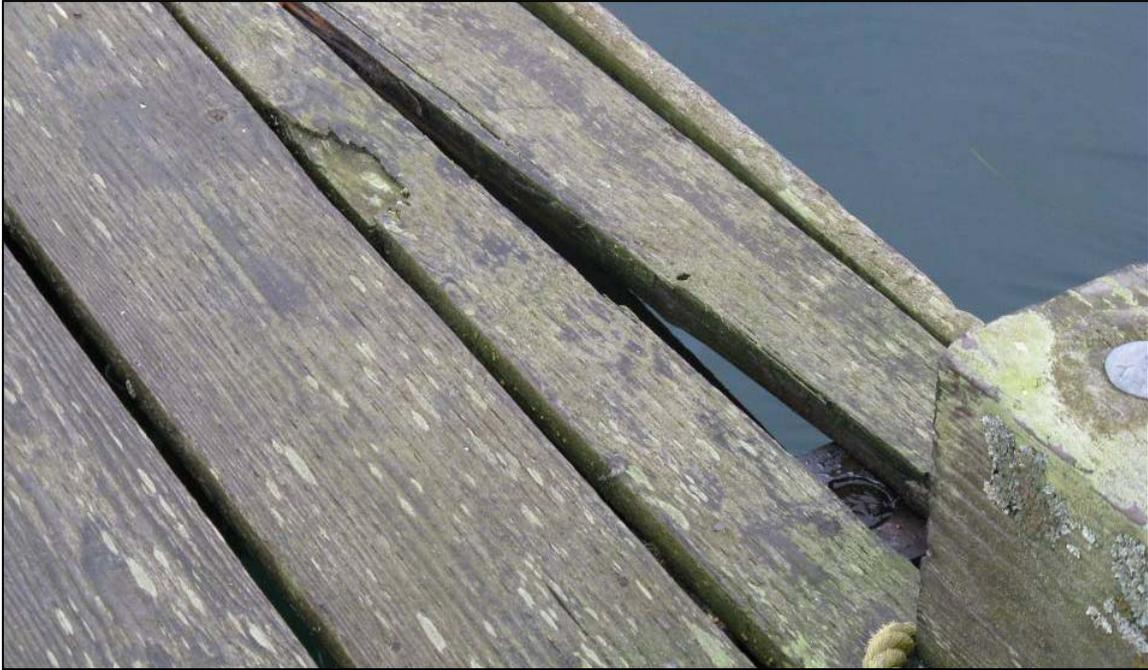
D Dock has worn decking and bull rails. Both appear solid, but have a fair amount of moss, wear marks, and cracking. In some areas, the bull rail has vegetation growing out of cracks. The finger piers are fastened using a pin system leaving the fingers to not be stable. The slippery nature of the decking in combination with the finger pier instability provides for a potential safety hazard. About 3 to 5 of the new metal piles are missing. 10 wood piles need to be removed. D dock has no finger piers to the north. If installed, these finger piers could provide more moorage.

Figure 11 - D Dock - Decking Damage

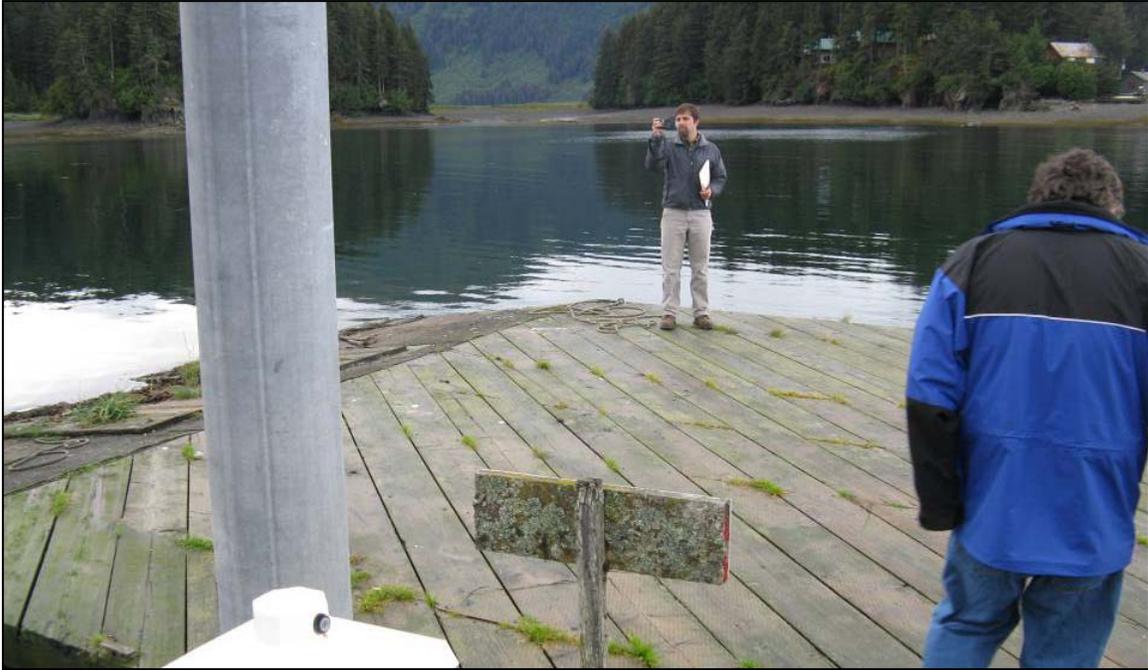
E Dock has worn decking and bull rails. Both appear solid, but do have a fair amount of moss, wear marks, and cracking. The finger piers are fastened using a pin system leaving the fingers to not be stable. The slippery nature of the decking in combination with the finger pier instability provides for a potential safety hazard. x of the new metal piles are missing. 14 wood piles need to be removed. E dock needs lighting. The floatplane dock attached to the outside end of E dock is very worn and needs replacing.

Figure 12 - Float Plane Dock

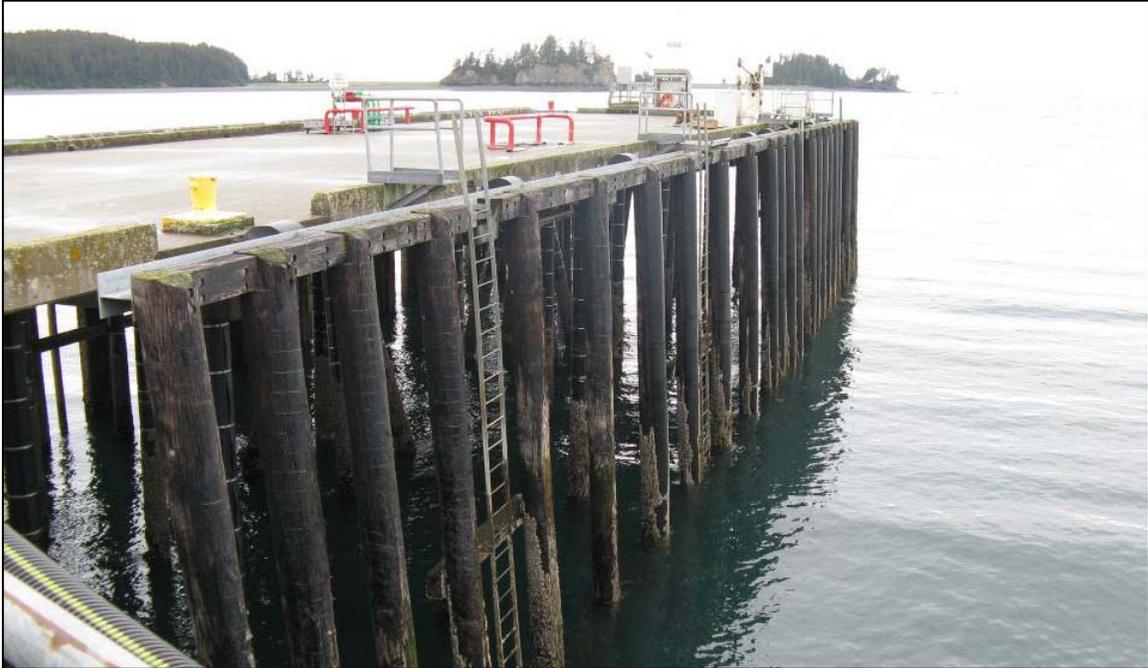
The city has their main dock located to the north of the boat harbor. The city reports no problems with the facility. Recent upgrades have improved the dock electrical system and have rehabilitated and/or wrapped several piling to extend their structural life span. The gangway utilized by the Alaska Marine Highway System (AMHS) is in poor condition, as well as the safety net that stretches out below the gangway. The city stated they are working with the AMHS and others on a plan to replace/fix these two issues.

Figure 15 - City Dock
