Village Safe Water Trip Report

REPORT DATE: 08/26/2012

LOCATION: Stevens Village (SVS)

PURPOSE: Inspection of 2011 scope of work completed by Summit consulting and perform a detail observation, gather data pertaining to deficiencies in existing lift station, water quality measures, and Water treatment plant modifications.

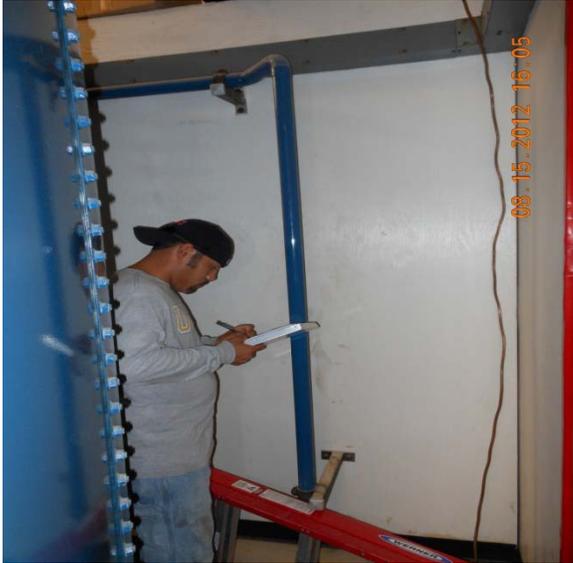
- The access to the manway needs an overflow pipe to be adjusted or door needs to open inside which contradicts with design.

Proposed man way access

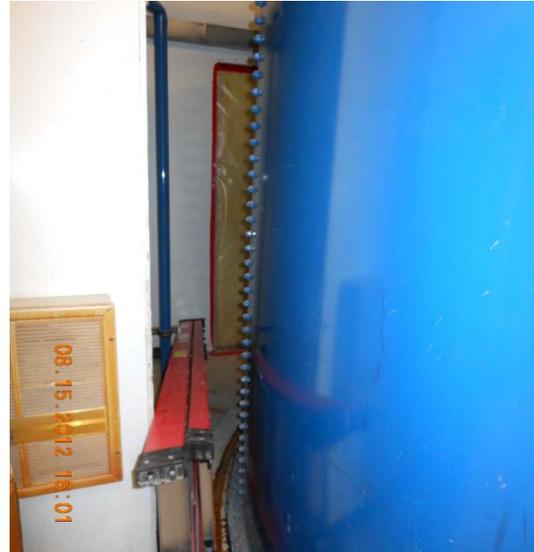
Narrow Space available for man way access

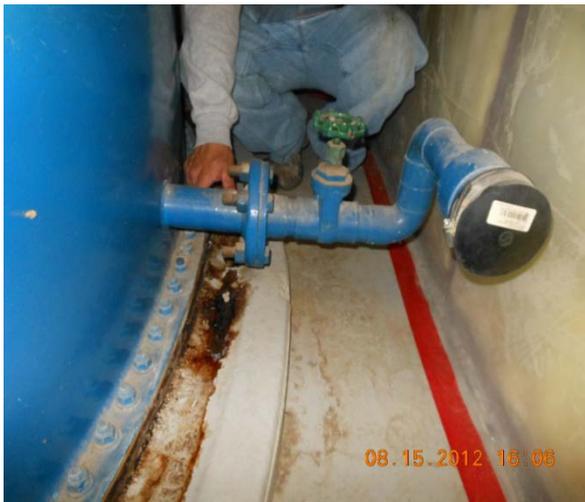
- There is no drain on the raw water tank to clean the sludge. The present outlet is elevated approximately 2" from the bottom of raw water tank which will filled with sludge, so there should be a provision incorporated in the tank to fulfill the purpose. This raw water tank was potable water tank before the upgrade so it has a confined top with 24" hatch for the access inside the tank which in my understanding in not enough. Operator Henry Smoke mentioned that he is scared to go inside the tank. The converted raw water tank needs frequent cleaning, at least once after every batch of water filtered. So the top cover should be modified to provide enough access for cleaning purpose. The access to the man way ladder of raw water tank has been restricted by preway oil heater. I could hardly fit through that passage, so that needs to be relocated or removed since it is not functional.

Existing drawline

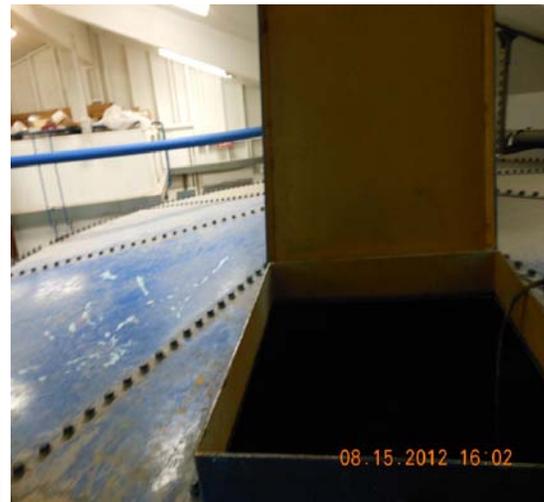
Raw water tank cover with 24" hatch

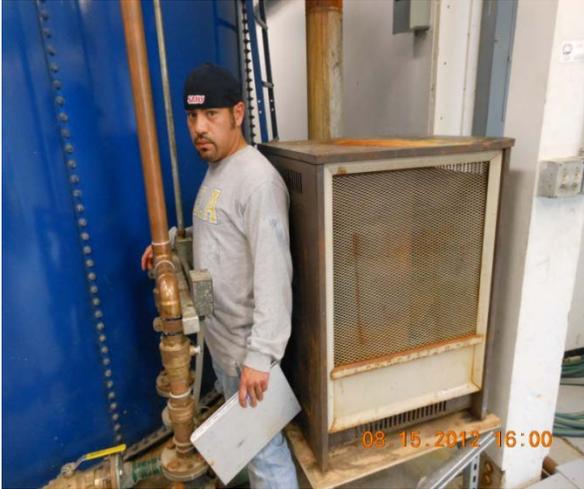
Narrow access to the man way ladder

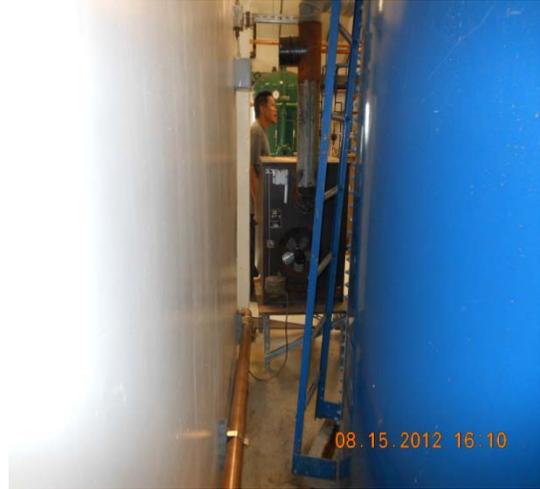
Rear view of the access blocked by oil heater

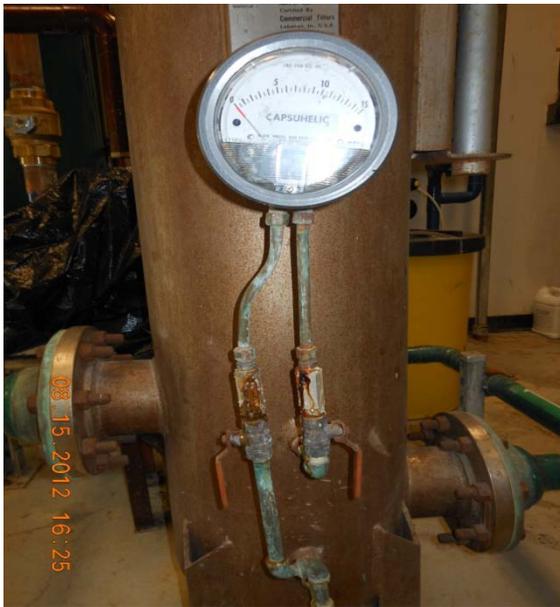
- Differential pressure gauges for polishing and backwash filter are not working at all. There are leaks in plumbing around the gauges.

Differential gauge for cartridge filter

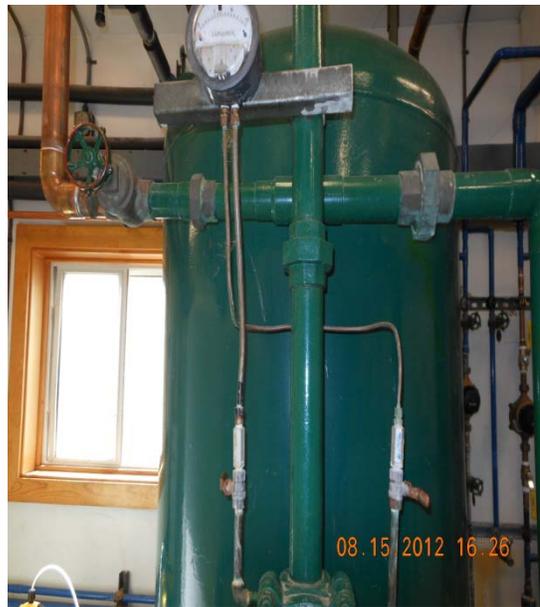
Differential gauge for mixed media filter

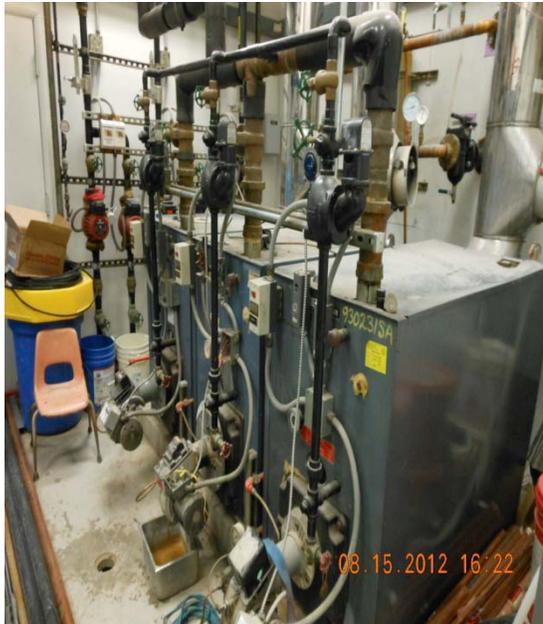
- All the waste water plumbing inside the plant was working well. Henry said that he did not discover any leaks so far. Operator recommended changing boiler #2, since it was not functional for a while. Arlo mentioned that he cleaned two boiler (#1 and #3), but boiler #2 was not operational at that time either due to a mechanical problem. Operator mentioned that they did not have enough fuel to run the boilers, so none of the boiler were running at that time, so all the heating requirement were fulfilled by waste heat from the power plant. Supplement heating was provided by small water heater. We also discovered that photovoltaic panels were installed in WTP roof and was connected to big water heater.

Three Boilers

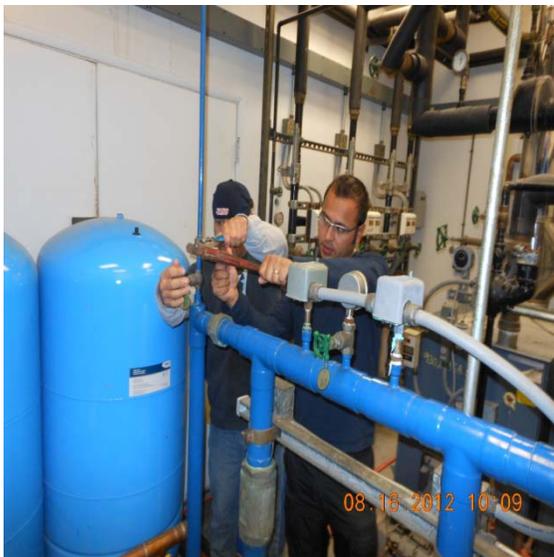
- We tried to isolate the potable water connection for boiler fluid, but the valve did not hold the pressure so left it as is for follow up.

Potable water line for boiler

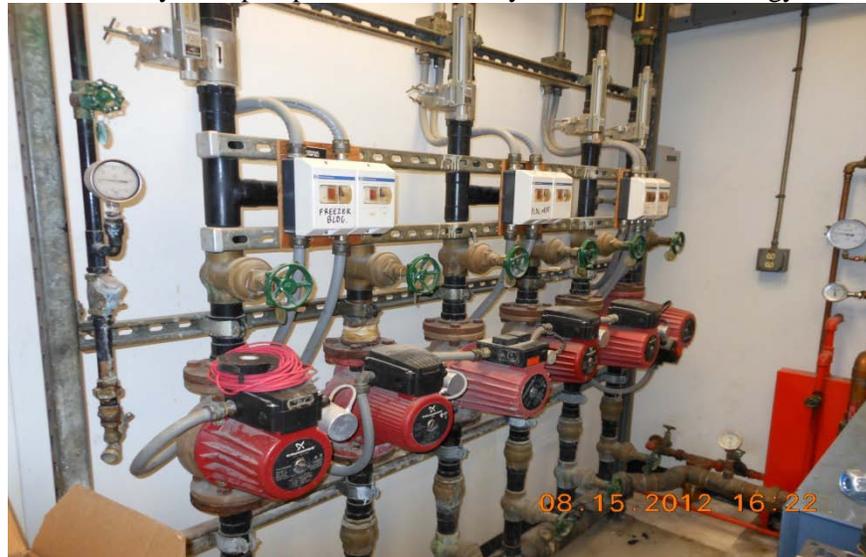
- All the boiler pumps are manual. The second pump for freezer building and WTP building heat has to be turned on manually. The pumps run continuously which hurts the energy consumption.

Boiler return pumps

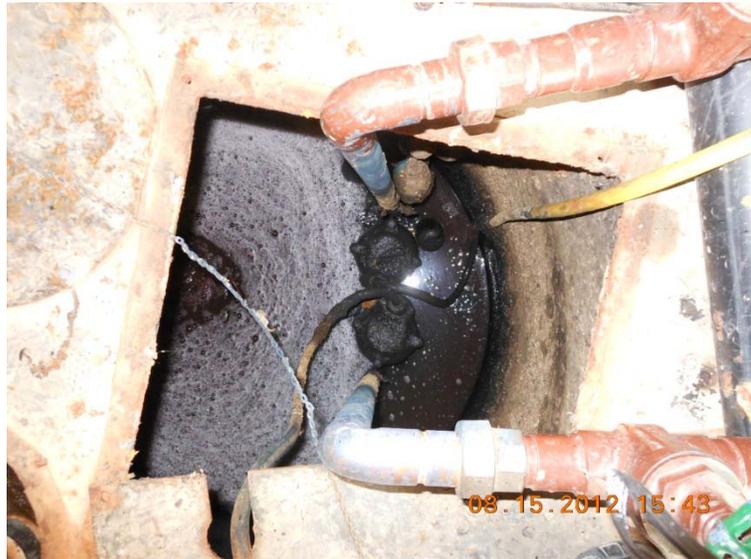
- Lift station well doesn't have enough volume to hold the back wash discharge and at the same time the lift station pumps are unable to keep with backwash flow rate. We did two separate tests to conform the findings. The results were:
Time taken to fill the wet well from low level to high high level (254 gal) = 2 min 40 sec, flow rate=95.25gpm
Time taken to drain the wet well from high high level to low level (254 gal) = 4min 30sec, flow rate = 56.4 gpm

So basically the flow rate of existing lift station pumps are approximately 60% of back wash discharge which results to overflow, short runs of backwash cycle , and more than 30 mins (to avoid the overflow) to complete the recommended backwash cycle (10-12 mins). So care should

Existing lift station pumps

be taken for new wet wells and the pumps installed to overcome above mentioned situations with considerable factor of safety.

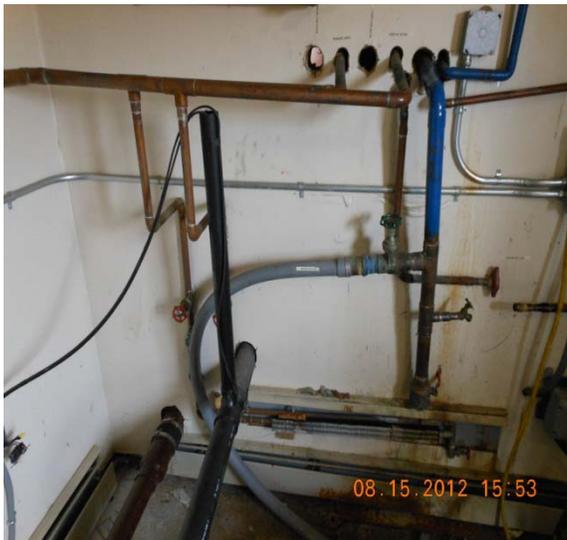
- Susceptibility of cross contamination of school water line which was lying on the lift station floor and goes around the wet well. Also the lift station is below 2009 flood plain.

School Water line lying on the floor

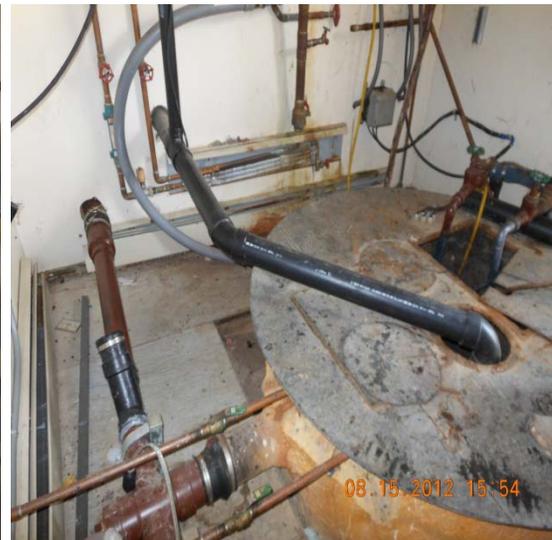
School Water line next to waste water line

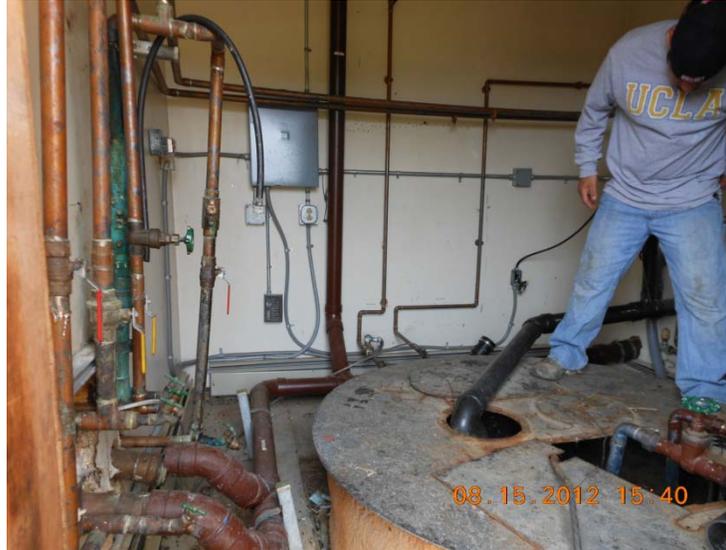
- Clinic waste water line appeared to be below the invert of the gravity outfall to wet well, but no measurements were taken.

Clinic waste water line

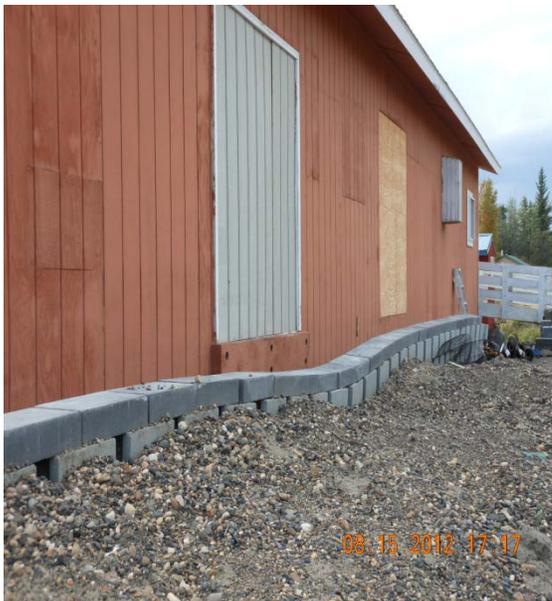
- Retaining wall is going through approximately 6"-8" of settlement. The base of the wall was buckling and some of the key stones were falling apart through the active pressure of infill materials. The alignment of the wall was not straight and was leaning inwards. The retaining wall and pad work was not completed in 2011 season

Retaining wall settled 6"-8"

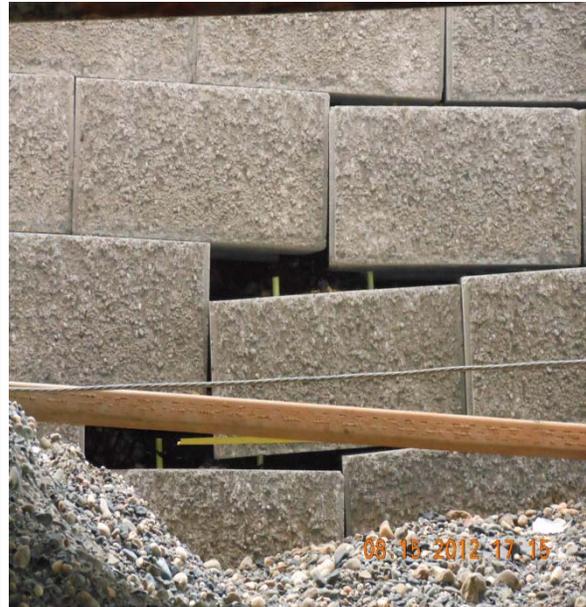
Retaining wall stones falling apart

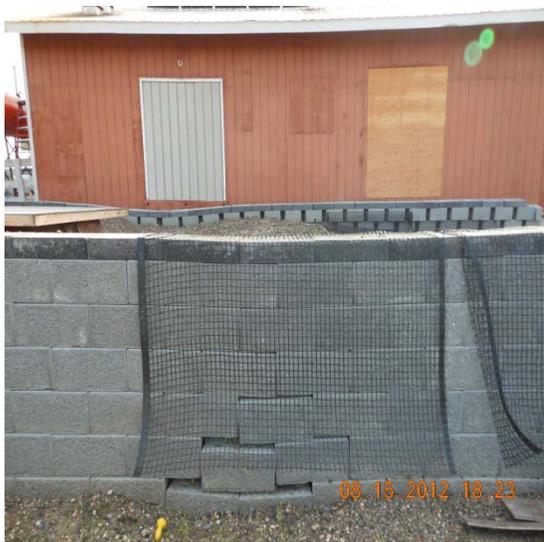
Another settled section of retainign wall

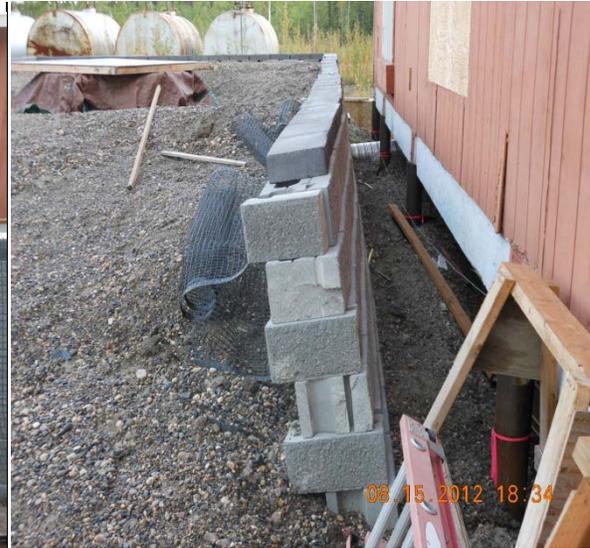
Improper wall alignment

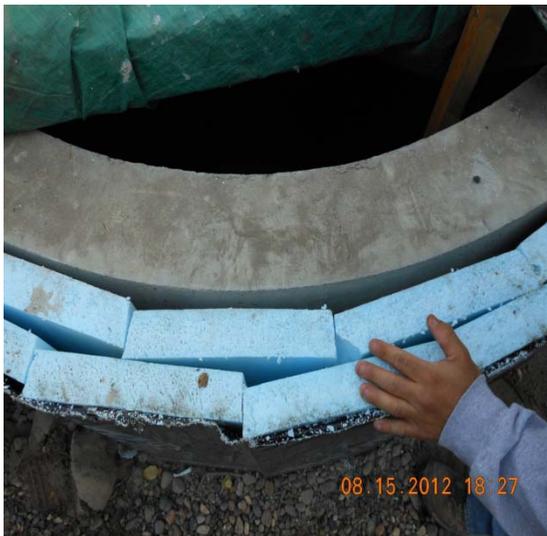
- The wet well was insulated by 2" board stock instead of pour foamed and there were lots of gaps in between the pieces of board stock. These gaps needs to be filled depending upon how far it goes or take the visible portion of existing insulation apart and do the pour foam.

Gaps on wet well insulation

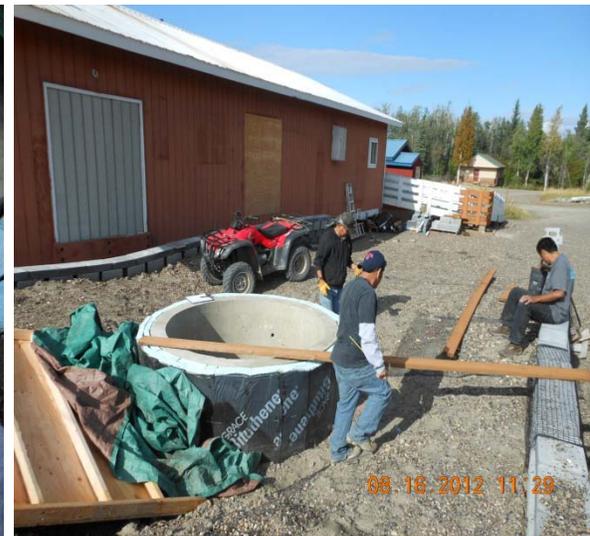
Incomplete pad and retainign wall

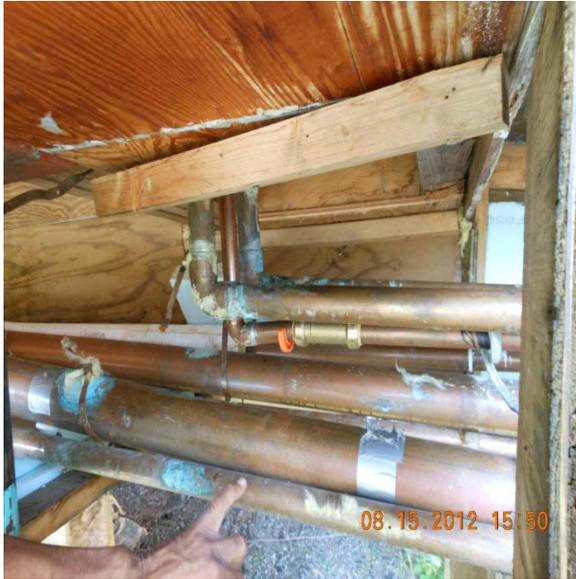
- The pipe inside the utilidor underneath the clinic has freezing issues. The utilidor was wide open and the operator said has been doing maintenance on copper piping, and joints cracks during winter.

Exposed utilidor underneath clinic

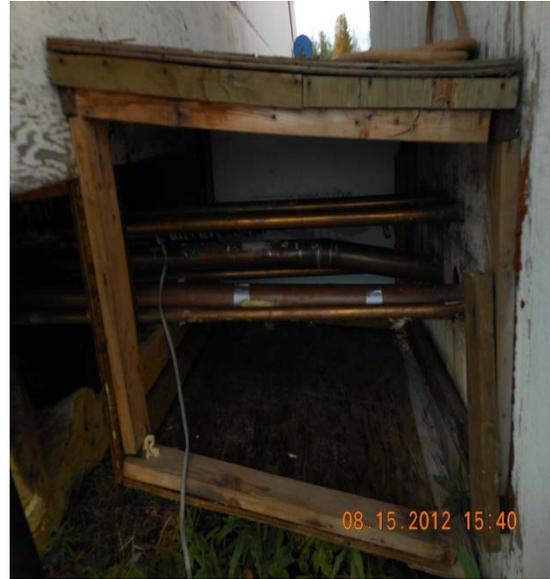
Exposed utilidor for maintenance

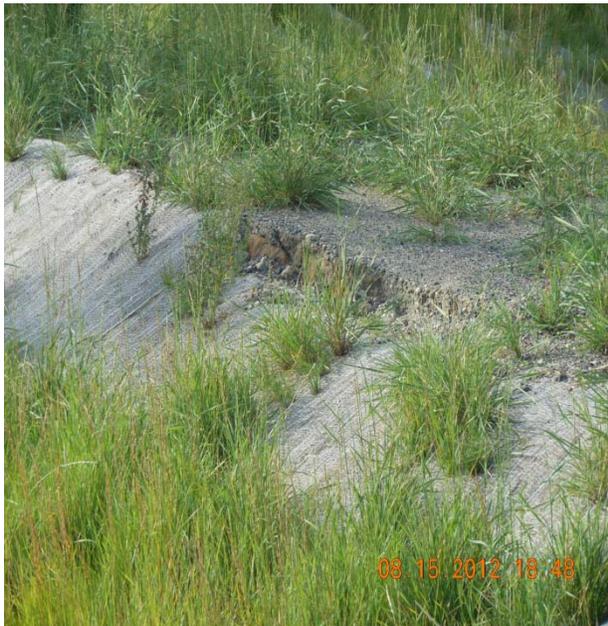
- We could not locate the thermosyphon sleeves. Upon having the conversation with one of the labor who worked on that in 2011 we came to know that it was buried underneath the pad and I am not sure if there are any swing ties for them.
- Vegetation growth in lagoon berms was not uniform. It needs to be properly seeded. I noticed that there was erosion in couple of places. Looking at the design the erosion was at the anchor points of erosion control mat on top width of lagoon. Since the gate was locked, I wasn't able to look around the lagoon, so there might be other eroded sections. The lagoon needs to be investigated and maintained as needed.

Eroded section of lagoon

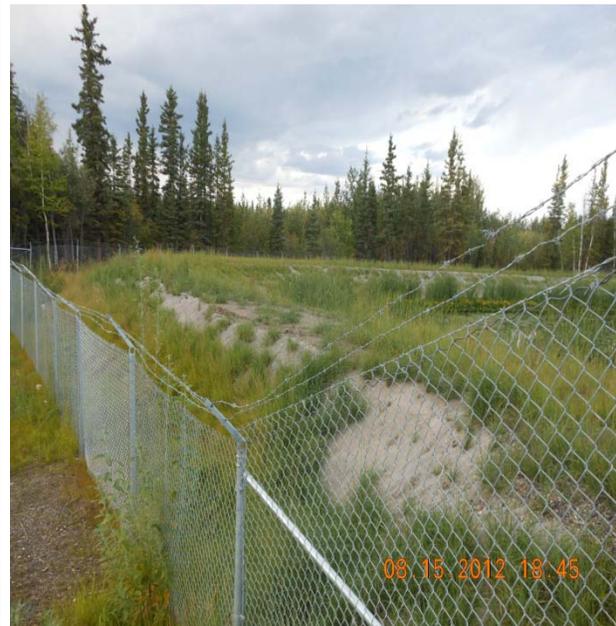
Non uniform vegetation growth

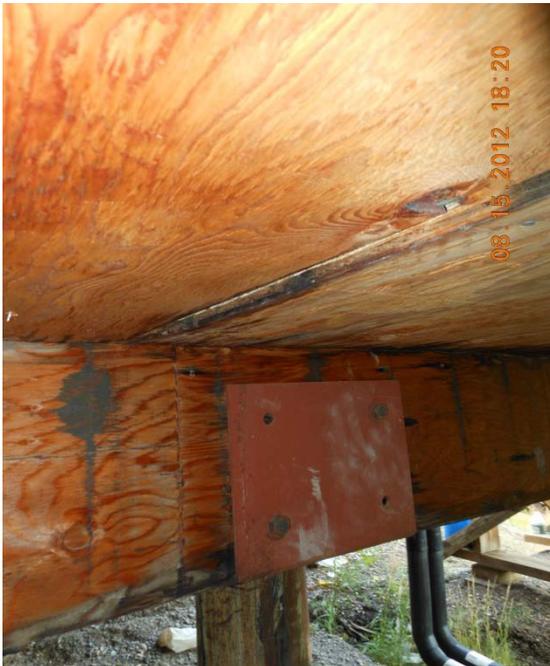
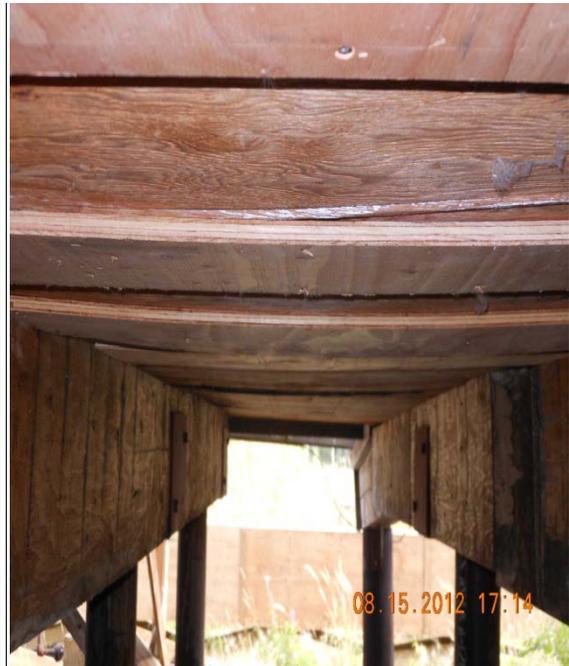
- The building was under the creep loading from a long time, so noticed some sag underneath the building. The section of building floor was repaired in 2011 season where old raw water tank was located.
