Site Visit Summary

Port Lions City Dock

June 23 – 24, 2009

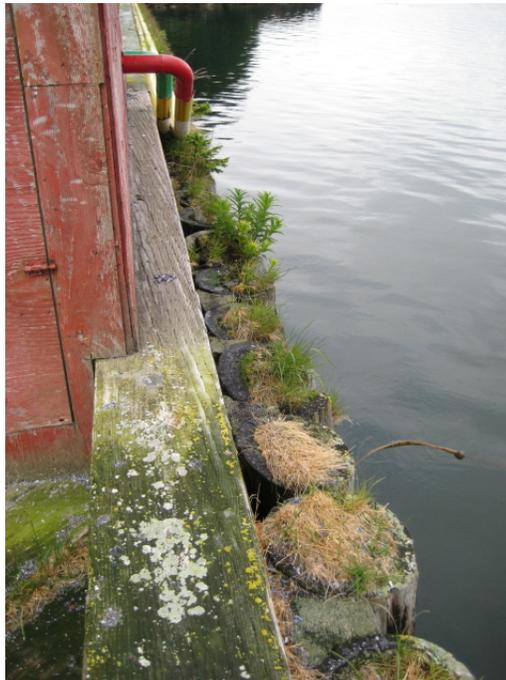
The tops ends of most of the piles along the outside of the dock are recessed and have vegetation growing in them.

Vegetation growing atop pile ends

Cut and cap outer piles to prevent vegetative growth

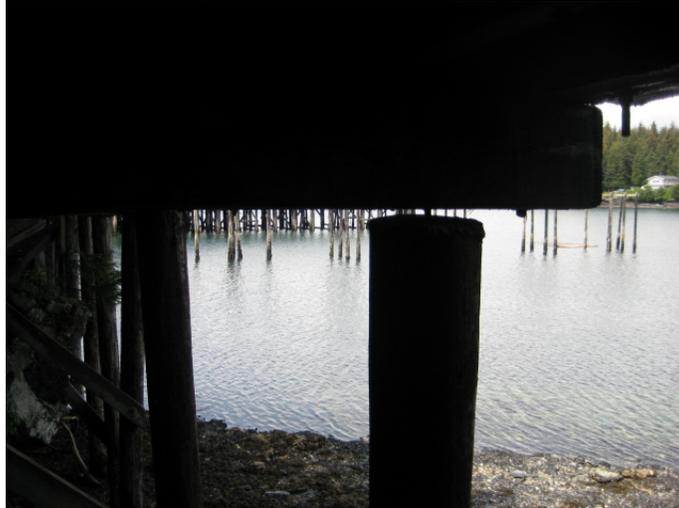
Multiple piles and drums were noted that are not touching the bottom of the deck.

Gap between pile and dock

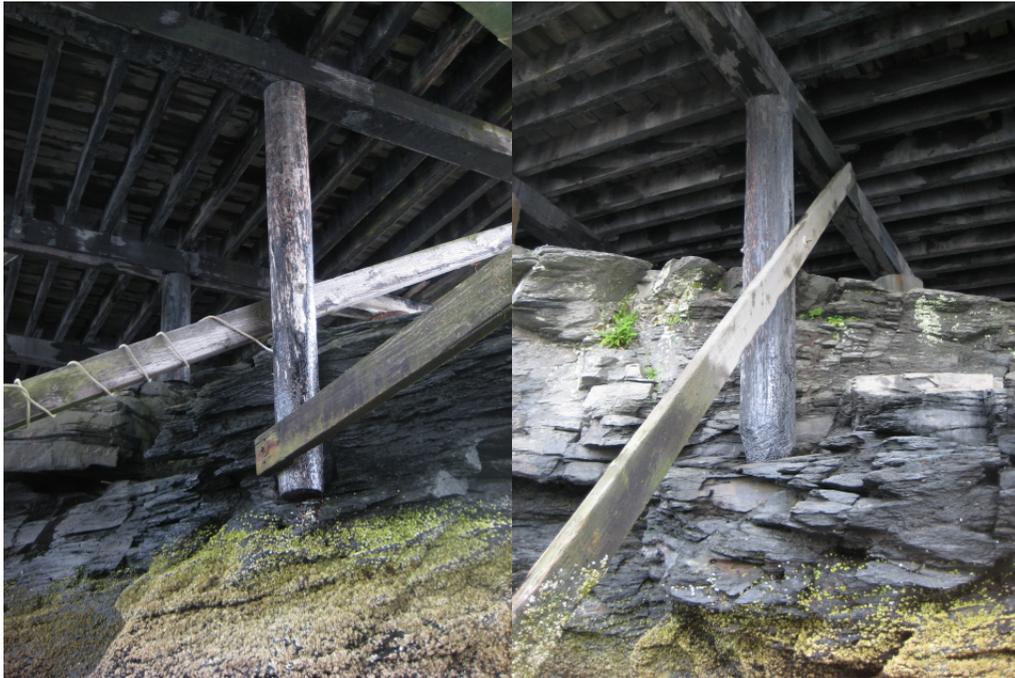
All bracing below a certain elevation are missing or obviously decayed.

A pile tapered at the bottom was noted resting upon bedrock.

Unbraced piles on bedrock

- Replace all bracing

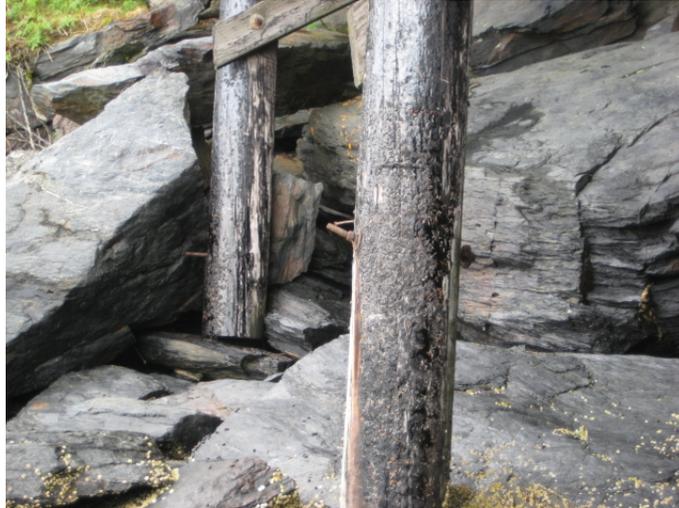
Bolts with nothing attached to them indicate a missing lowest level of cross bracing.

Unbraced piles on bedrock with bolts indicating missing bracing

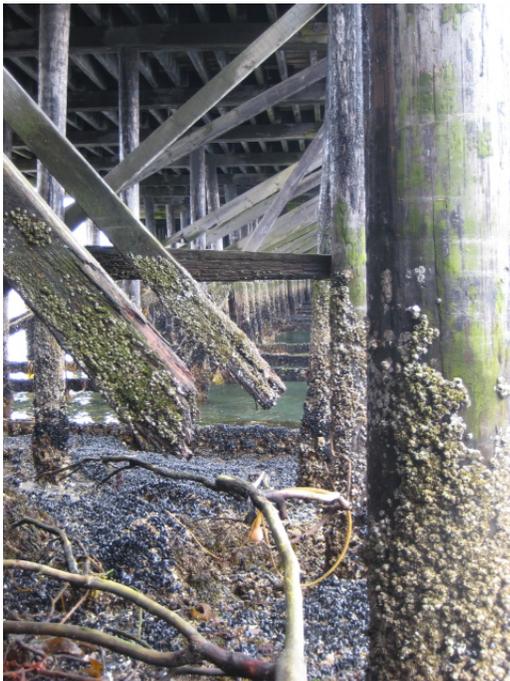
View underneath causeway

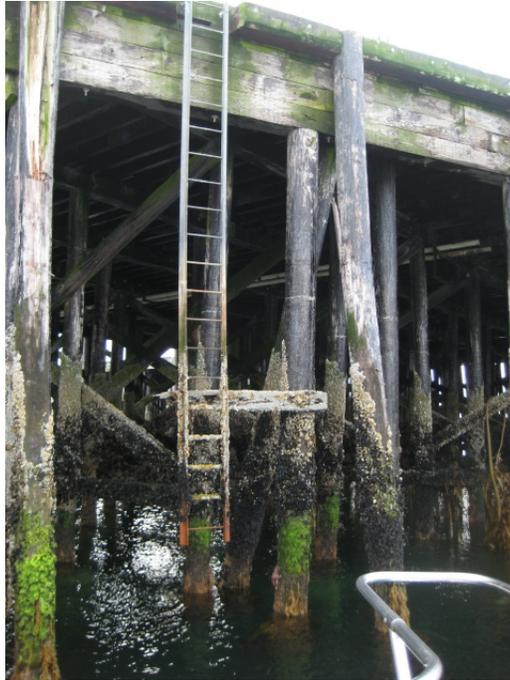
Bracing for the dock ladders are missing. The ladders are only supported by their attachment point to the dock at the top of the ladder. This is a safety concern.

Dangling ladder missing supports due to decay of bracing

- Replace ladders

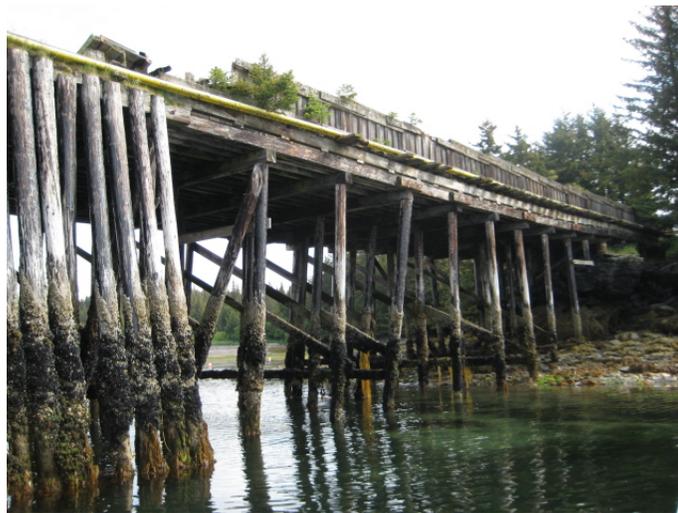
Crooked, non-vertical piles are obvious, especially in the outer piles. While many are batter piles, intended to be non-vertical to add horizontal stability by providing a wider base, others were not intended to be non-vertical (narrower base).

Numerous crooked, non-batter piles were observed.

View showing misaligned pile under causeway

- Replace some piles (timber and concrete)

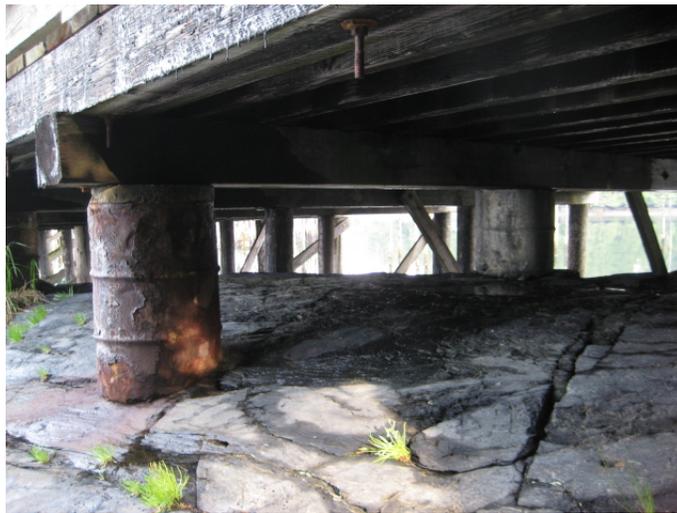
The causeway portion of dock is partially supported by concrete filled drums, some of which have eroded away from the concrete within. We observed no bracing at the top or bottom of these drums.

Unbraced concrete barrel supports atop bedrock under causeway

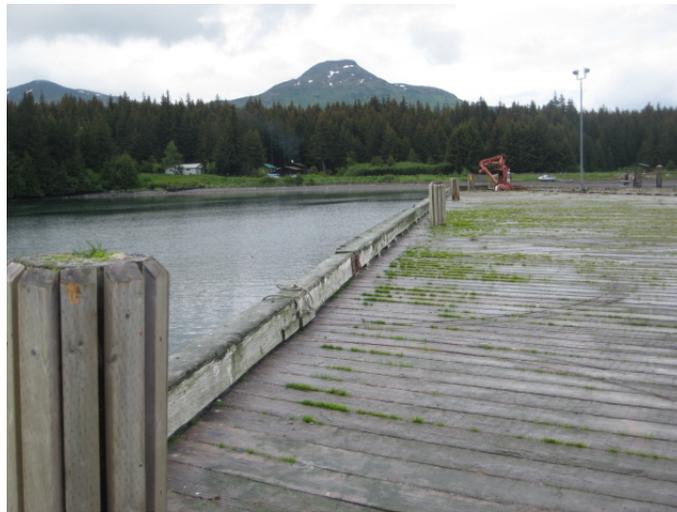
New surface decking was constructed directly atop old decking material. This prevents adequate drainage through the decking. There is much vegetation, mostly grass, sprouting out of the cracks of the decking. Small trees were also observed, especially along the perimeter on the deck and along the bulk fuel lines.

Typical dock surface with vegetative growth

Replace decking

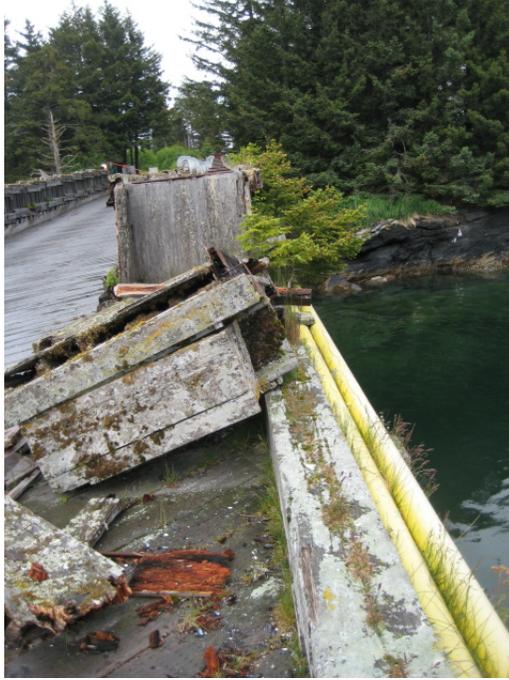
Throughout the dock there is antiquated equipment including, pipes, pumps, and decaying wooden live crab traps, mostly related to its origin as a cannery dock. Removal of this equipment may be a consideration as part of any dock repair efforts.

Decaying live crab pots, fuel lines, and vegetative growth including trees

Remove live crab tanks

Remove old equipment
