# ALASKA DISTRICT TRIP REPORT

**Project:** Denali Commission Mooring Points Phase 4

**Description:** Stevens Village Trip Report

**Date:** 19 August 2011

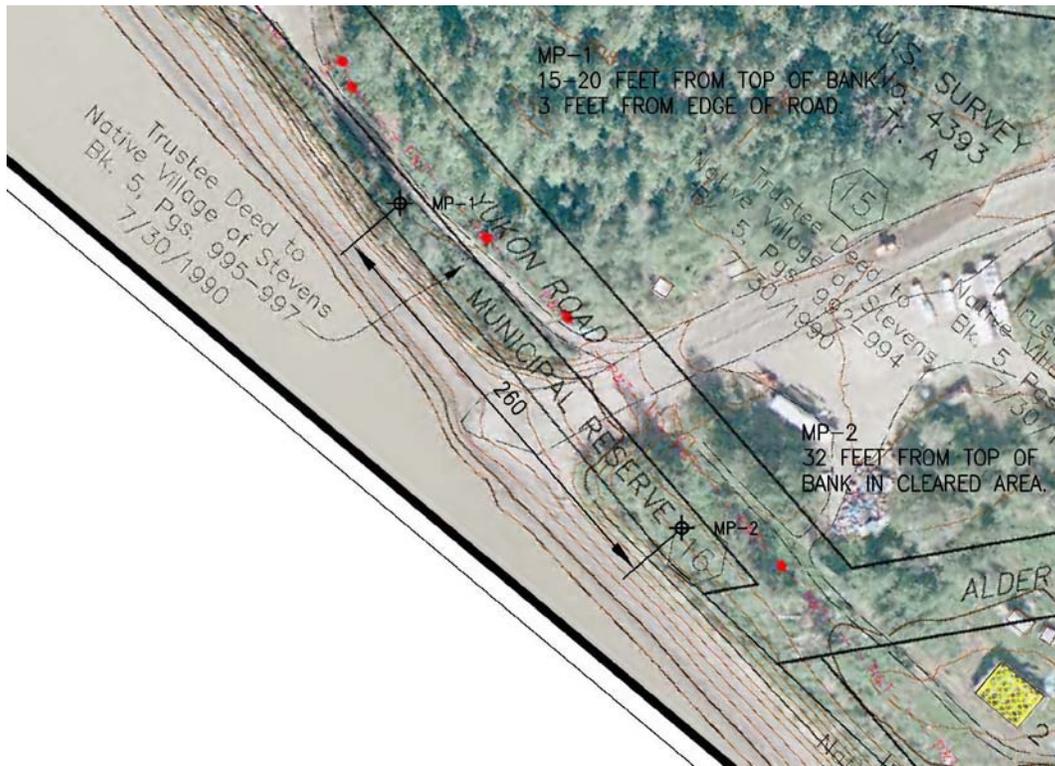
**Figure 2. Freight landing mooring points**

An upstream, above grade freeze back pile mooring point (MP-2) is proposed along the upstream edge of the clearing, approximately 20 feet from the road and telephone wires and 32 feet from the top of bank (Photo 4, Figure 2). Coordinates of this location are 66.00780°N, 149.10167°W.

A downstream, above grade freeze back pile mooring point (MP-1) is recommended between the road and top of bank, approximately 165 feet downstream from the ramp (Figure 2). This location is heavily brushed and will require clearing (Photo 5). The proposed location is 15 to 20 feet inland from the top of bank and is adjacent to a white birch tree (Photo 6). Coordinates of this location are 66.00835°N, 149.10281°W.

Both mooring points at this site require clearing of brush on the bank. It is recommended to clear brush to 1 foot above ground in a 45-degree swath facing the river with the apex centered on the mooring point.

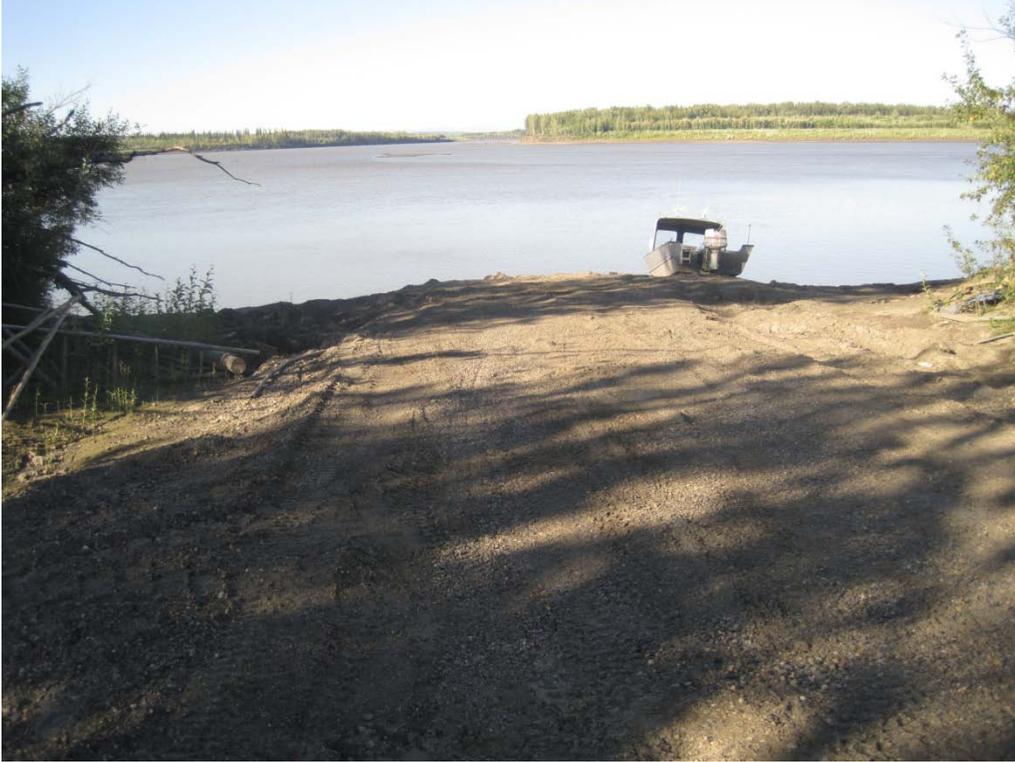
This landing consists of a gravel ramp perpendicular to the river (Photo 1) with a staging area on the upstream side of the access road to the ramp (Photo 2). Materials for a road construction project were stored at the staging area during the time of our visit. Two boats were beached above the water at this site during our visit.

Photo 1. Freight landing ramp

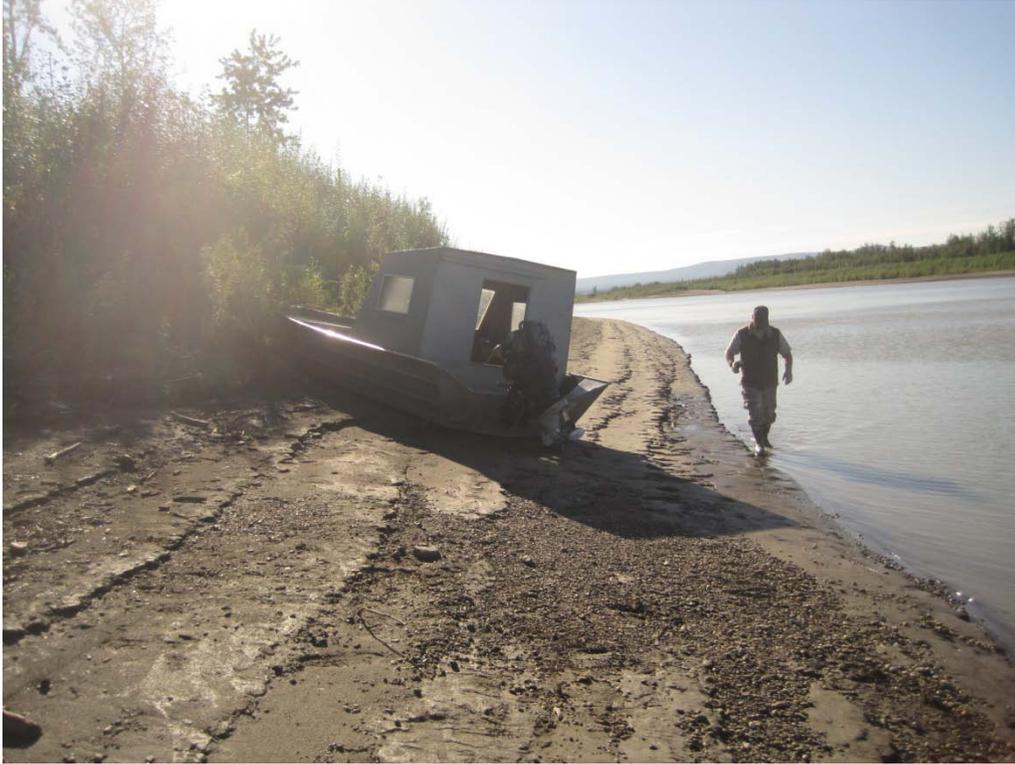
A gently sloped, terraced beach of fine grained soil (Photo 3) was both upstream and downstream of the gravel ramp. The terraced beach indicated higher flows prior to our arrival.

Photo 3. Terraced beach of fine grained soil upstream of freight landing ramp

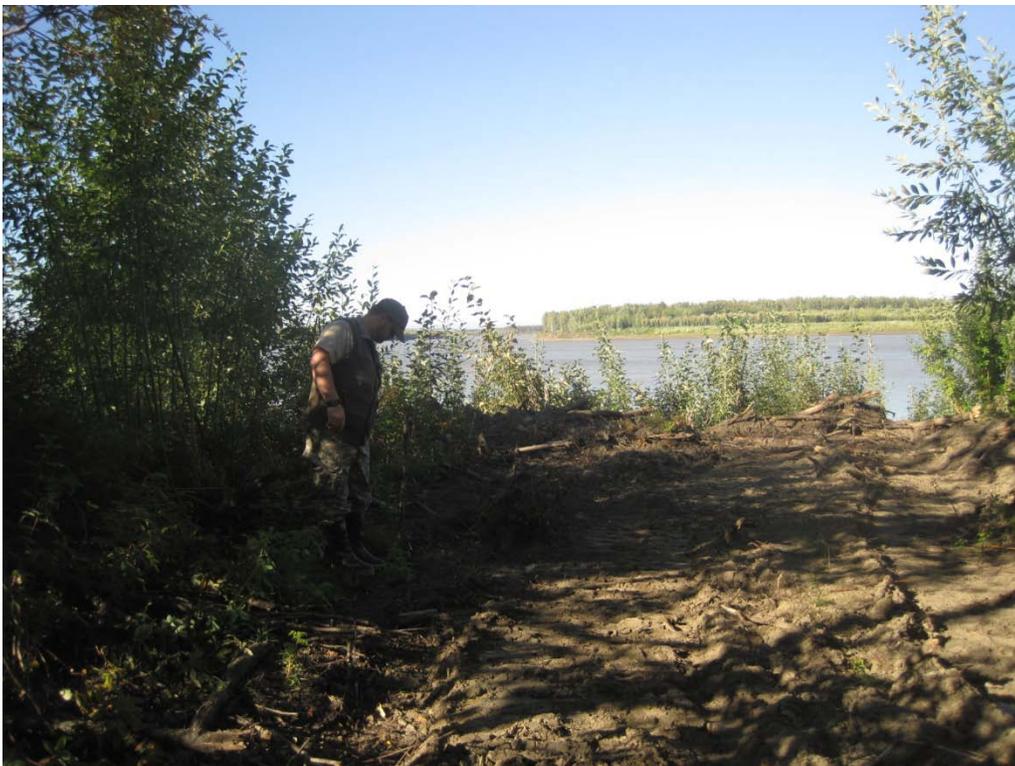
Photo 4. Corps engineer standing at location of proposed upstream mooring point MP-2.

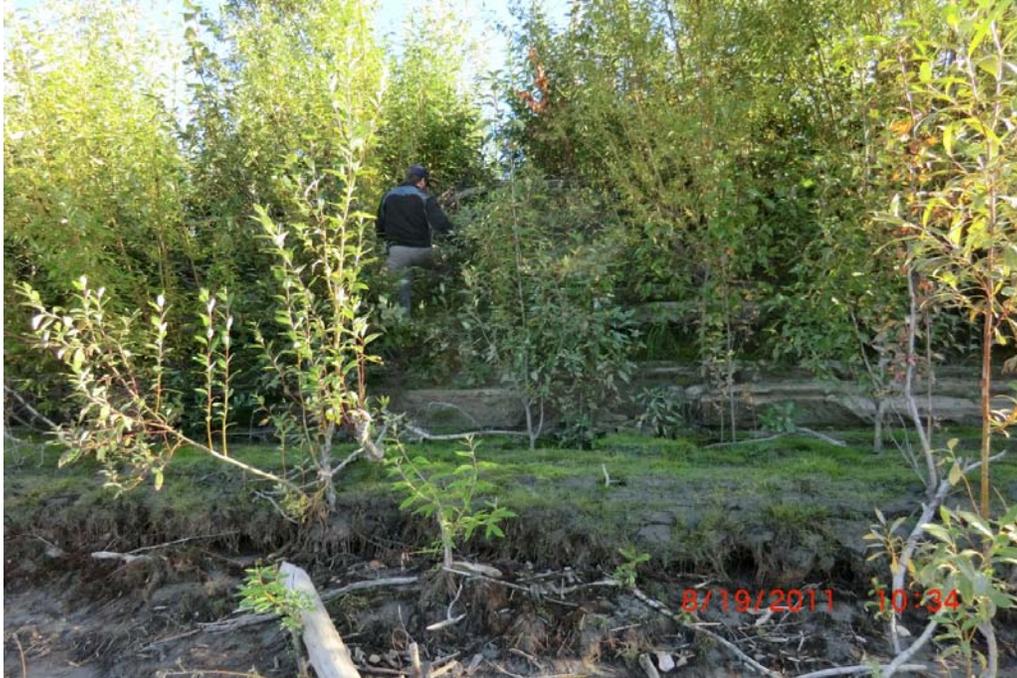
Photo 5. Corps planner standing near the top of the bank near downstream mooring point MP-1. Note heavy brush.

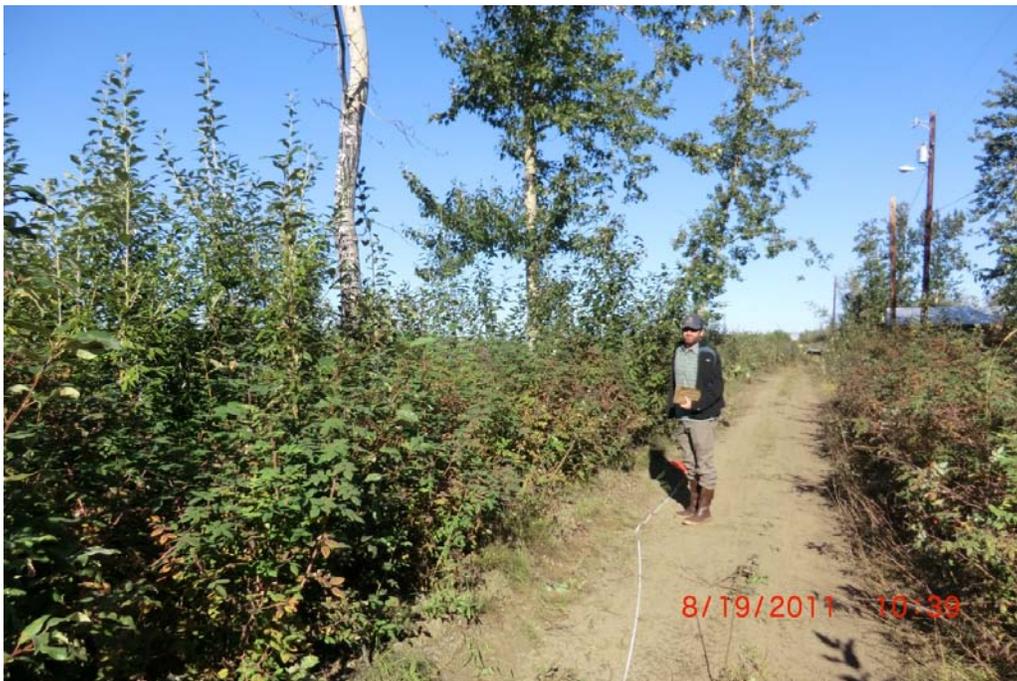
Photo 6. Corps planner standing near the location of downstream mooring point MP-1. The mooring point will be located about 3 feet from the edge of this road towards the river.

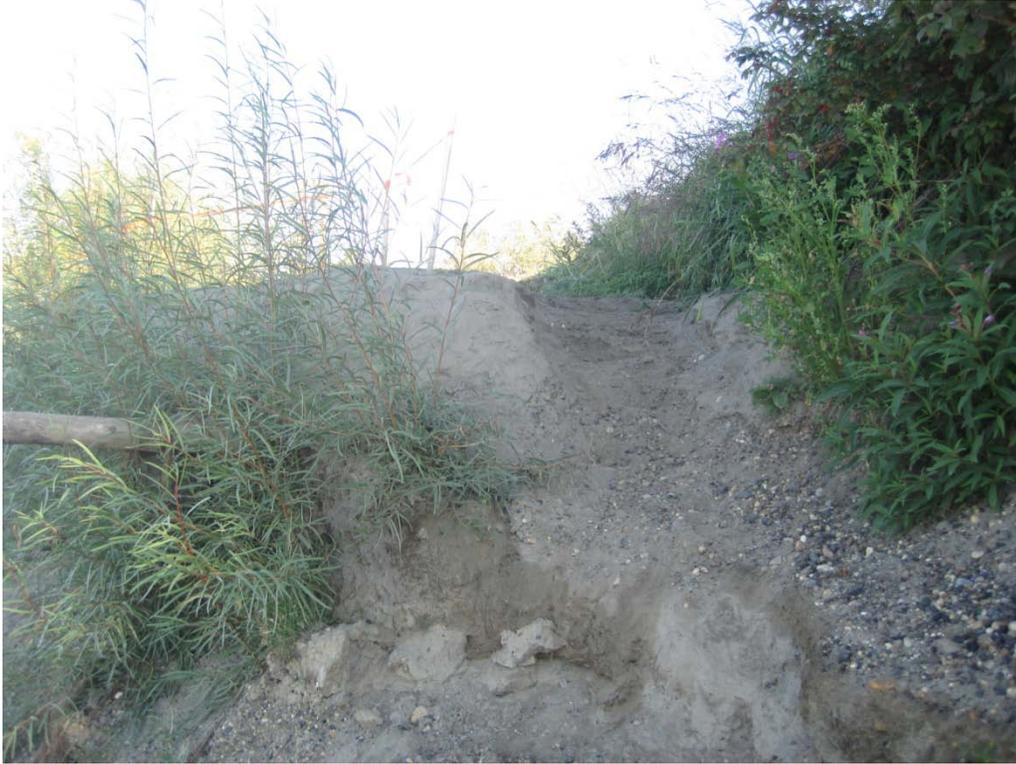
This landing site used to have a ramp angling down to the river; however, a majority of it was washed away during a high water event in 2009. The remains of the ramp still provide foot access between the river and the top of bank, but it is not suitable for any vehicular access (Photo 7). According to Pete Hjelm, this landing was the main freight landing for the village prior to the washout of the ramp.

Photo 7. Remnants of ramp that provides foot access between Yukon River and top of bank

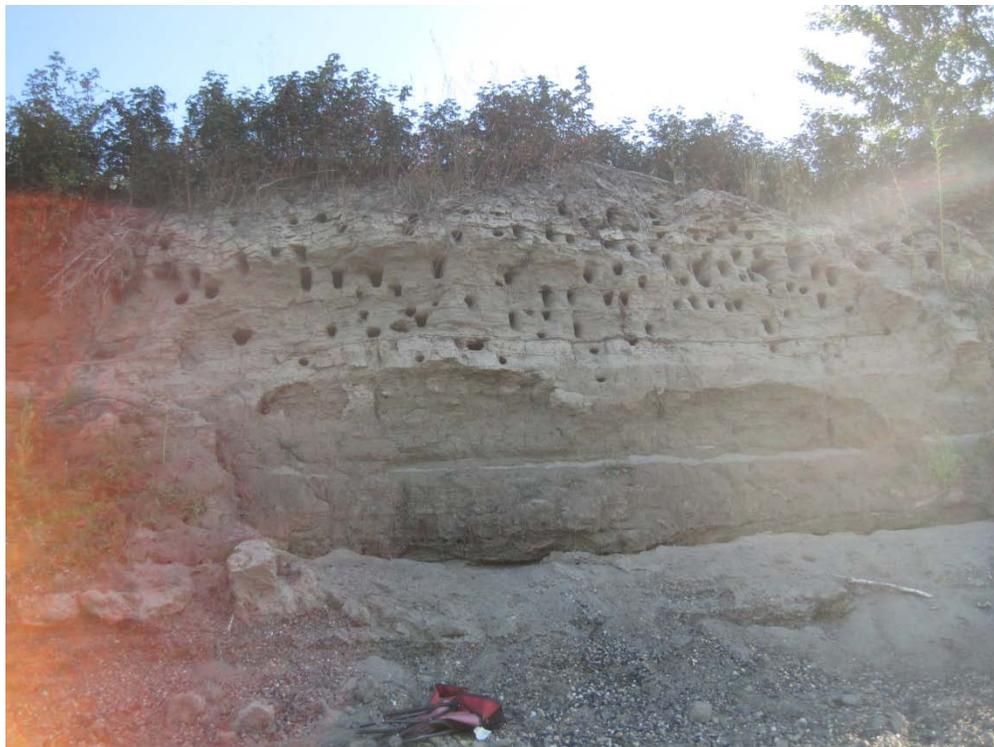
The stream bank along this landing has a vertical portion approximately 20 feet high (Photo 8). Below this, a terraced beach of sand and fine grained soil extends approximately another 10 feet to the edge of the water (Photo 9). The terraced beach indicates higher flows prior to our arrival. There are numerous bank swallow nests within the vertical portion of the bank (Photo 8).

Photo 8. Vertical stream bank with bank swallow nests

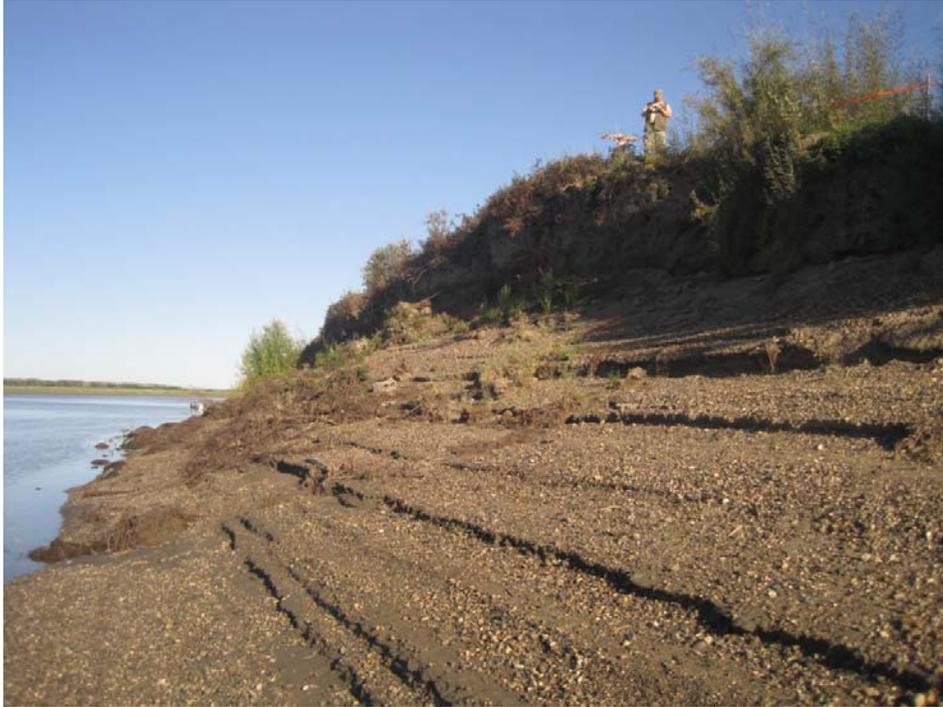
Signs of stream bank erosion in the form of small clumps of vegetation that have fallen from the top of bank were observed (Photo 9), but overall, erosion rates appear to be slow. The thalweg of the channel appeared to be on the opposite side of the channel during our visit.

Photo 9. Terraced beach between Yukon River and vertical streambank. Note small clumps of eroded vegetation.

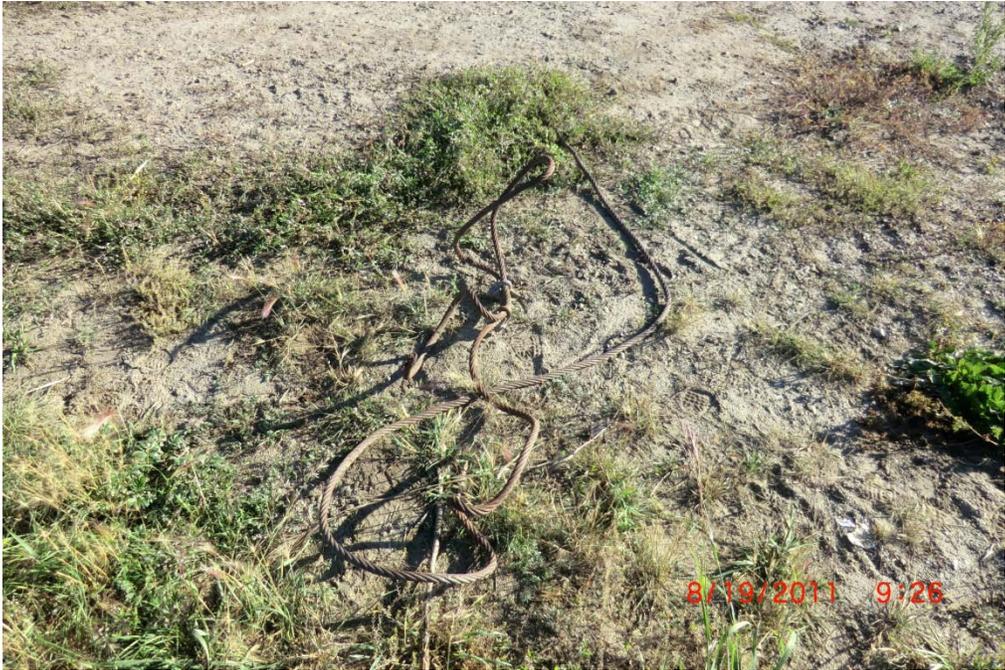
An existing tie-down cable was observed just downstream of the top of what remains of the ramp (Photo 10). Coordinates of this location are 66.00541°N, 149.09444°W.

Photo 10. Existing tie down cable at MP-3.

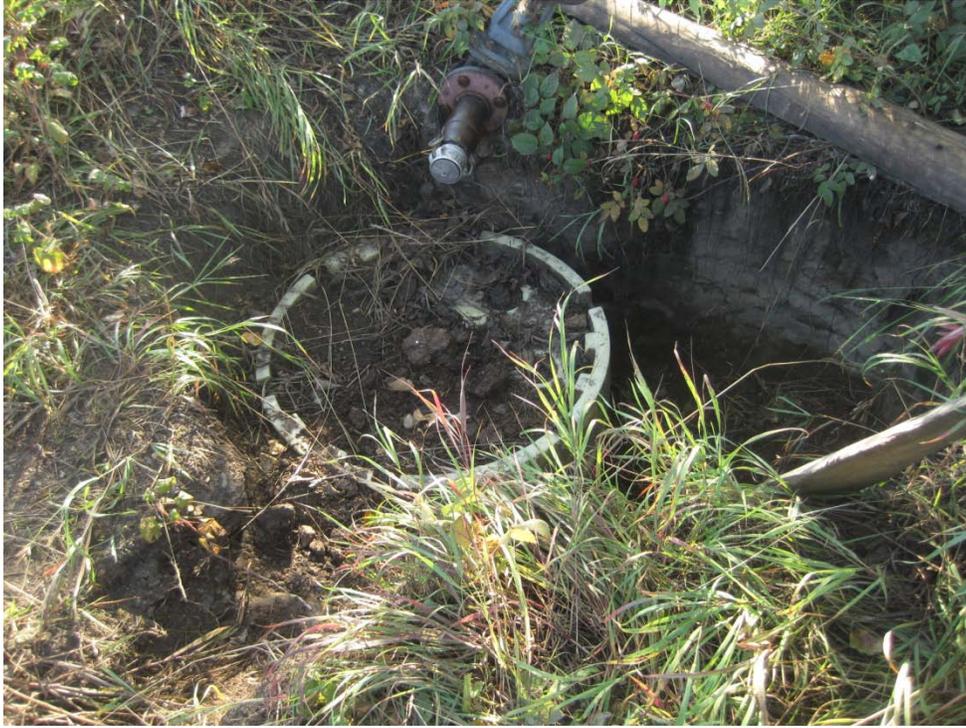
A fuel header is approximately 150 feet upstream of the tie down cable. The header itself is located on the ground with a small pit excavated beneath it (Photo 11). A small containment vessel is directly beneath the header. Coordinates for the fuel header are 66.00525°N, 149.09354°W.

Photo 11. Fuel header

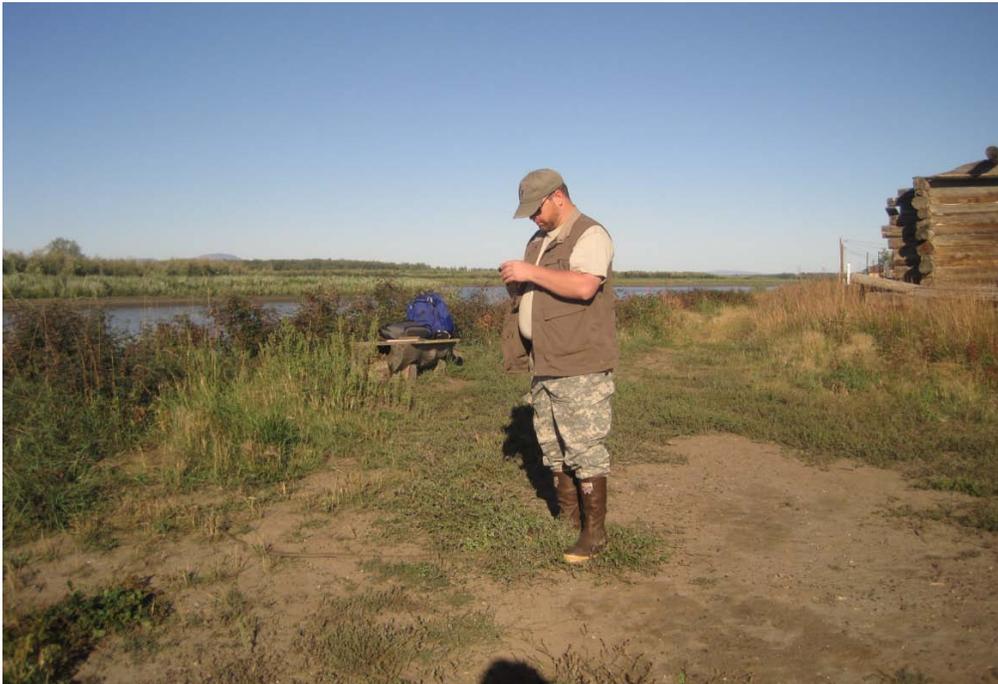
A private structure is adjacent to the top of the bank located downstream from the landing site (Photo 12).

A downstream, below grade freeze back pile mooring point (MP-3) is recommended adjacent to the existing tie down cable at coordinates 66.00541°N, 149.09444°W (Photos 12-13, Figure 3). An additional freeze back pile mooring point (MP-4) is recommended 220 feet upstream from

Photo 12. Corps engineer standing at proposed location of downstream mooring point MP-3, looking downstream. Note private structure to the right.

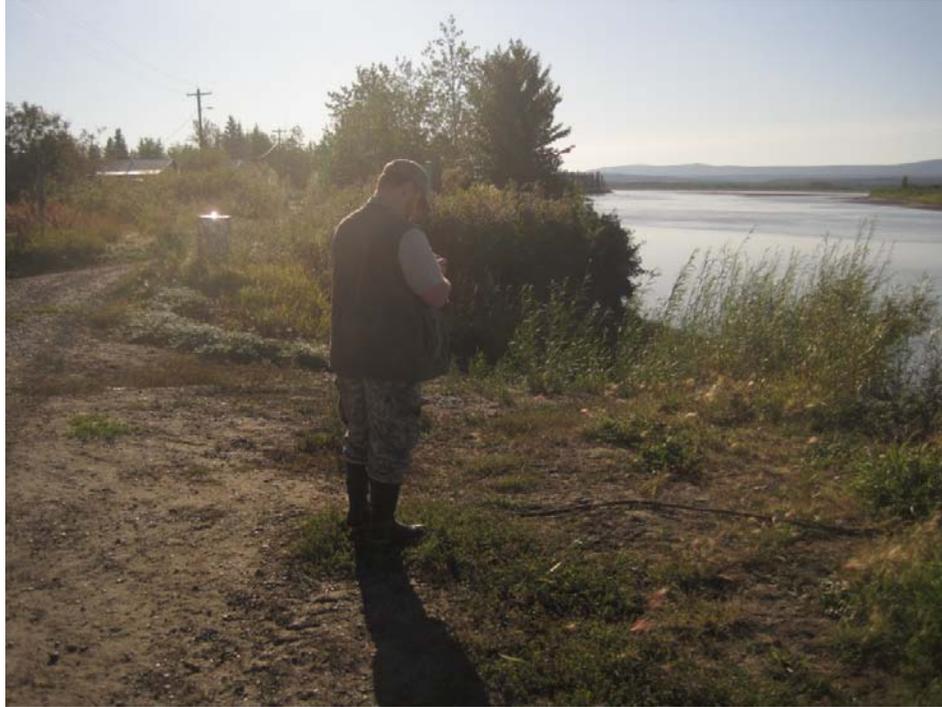
Photo 13. Corps engineer standing beside existing tie-down cable at the proposed location of downstream mooring point MP-3, looking upstream. The top of the ramp is beyond the Corps employee.

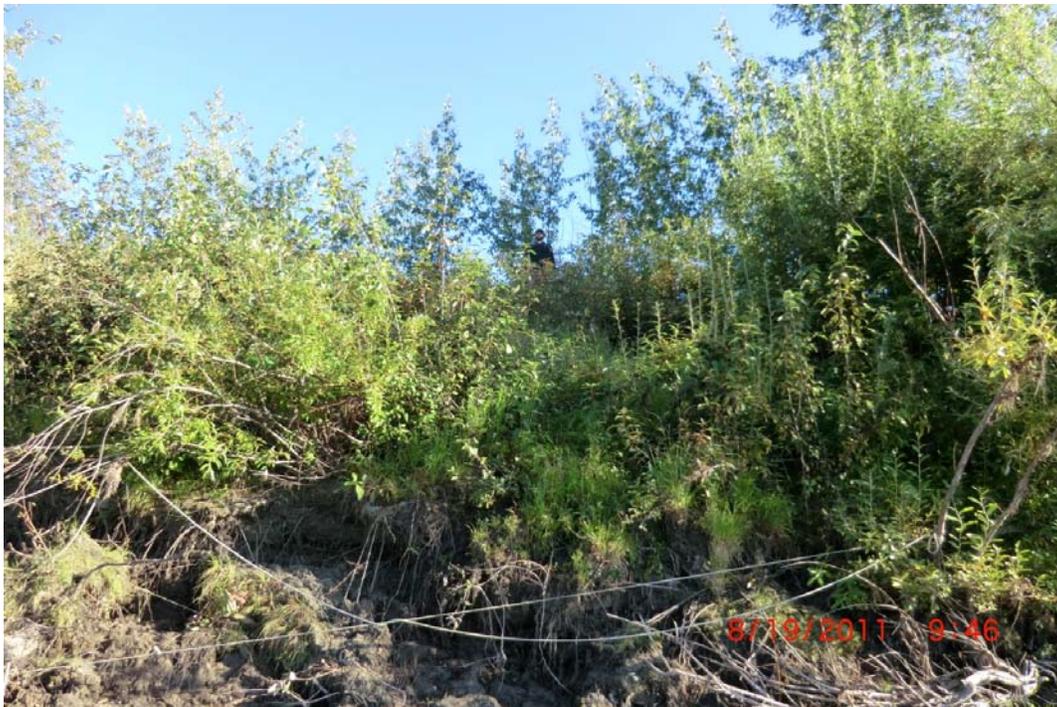
Photo 14: Corps planner standing near upstream mooring point MP-4. Some brush clearing will be needed to give the mooring lines a clear path from the vessel to the mooring point.

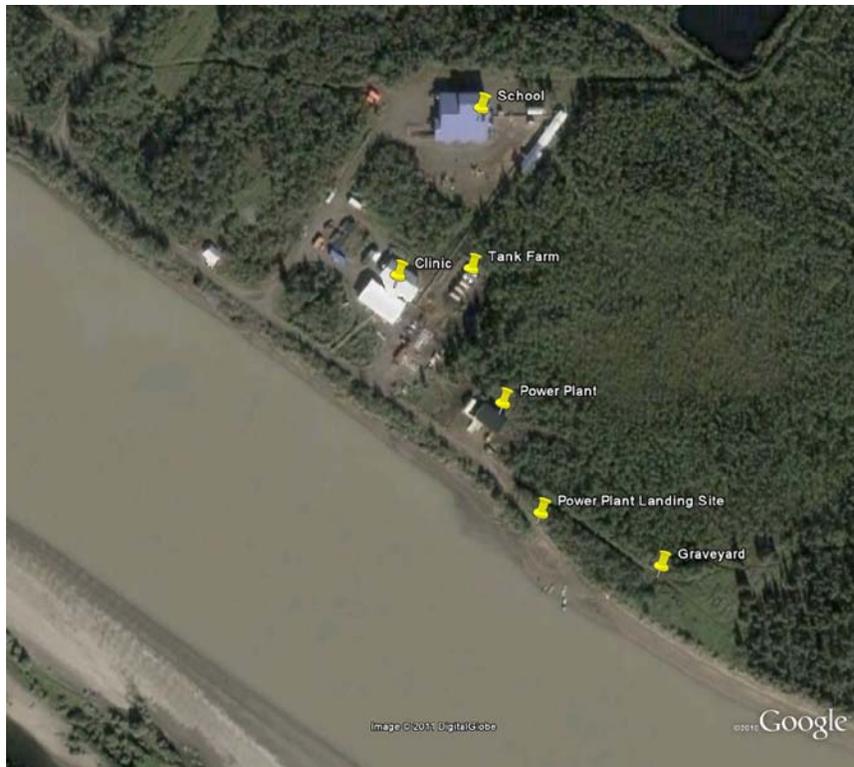
**Figure 4. Stevens Village Power Plant Landing and adjacent facilities. Yukon River flows from right to left.**

This landing consists of a gravel ramp angling down to the river (Photo 15). The village power plant is adjacent to the top of the ramp. The village school, clinic, and fuel tank farm are also nearby (Figure 4).

A road parallels the top of bank both upstream and downstream of the landing (Figure 4). The narrow spacing between the roadway and the river bank downstream of the ramp precludes the installation of mooring points.

A graveyard is upstream of this landing site (Figure 4).

This landing appears to serve as a skiff landing. Since it does not regularly accommodate barges, no mooring points are recommended for installation at this landing.

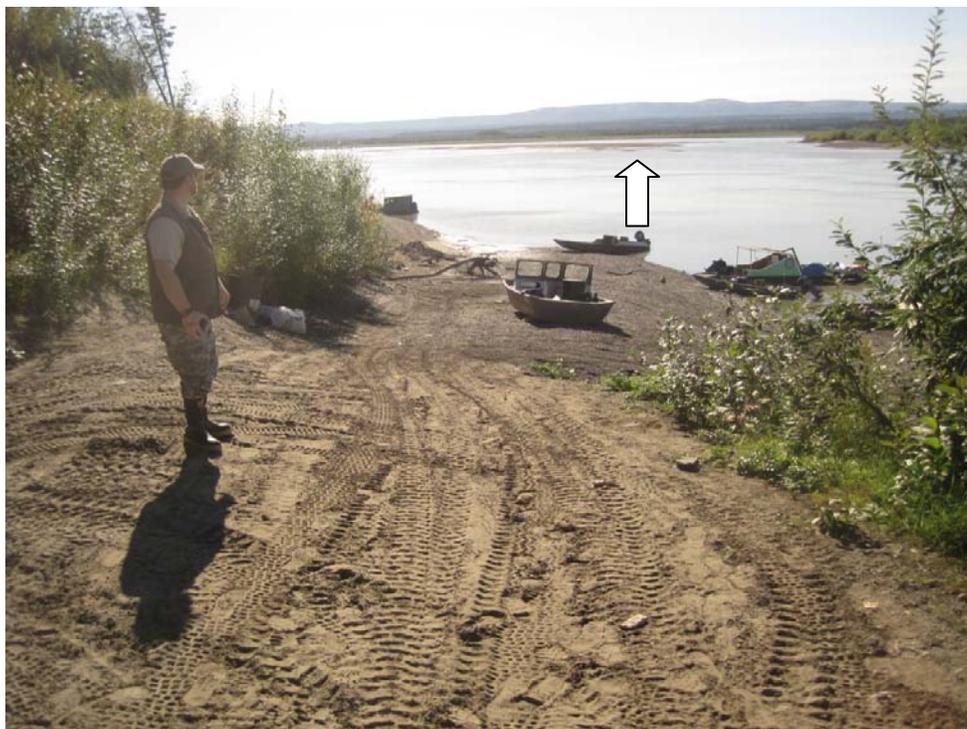
The river near this landing appeared to be shallow. Emergent gravel bars were within the river channel. One can be seen in the distance in Photo 15.

**Photo 15. Power plant landing ramp looking upstream. Arrow indicates location of a gravel bar used as a material source by the community.**

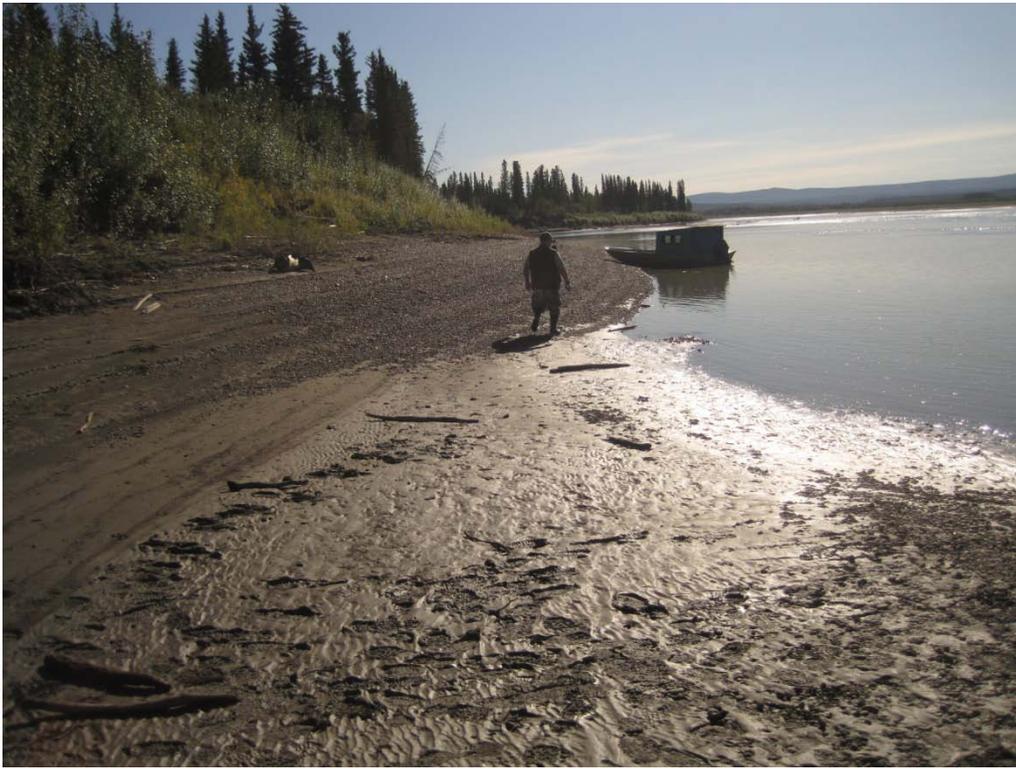
The beach along the river upstream of the ramp consisted of sand and gravel (Photo 16) while the beach downstream consisted of fine grained soil (Photo 17).

Photo 16. Looking upstream from power plant landing ramp

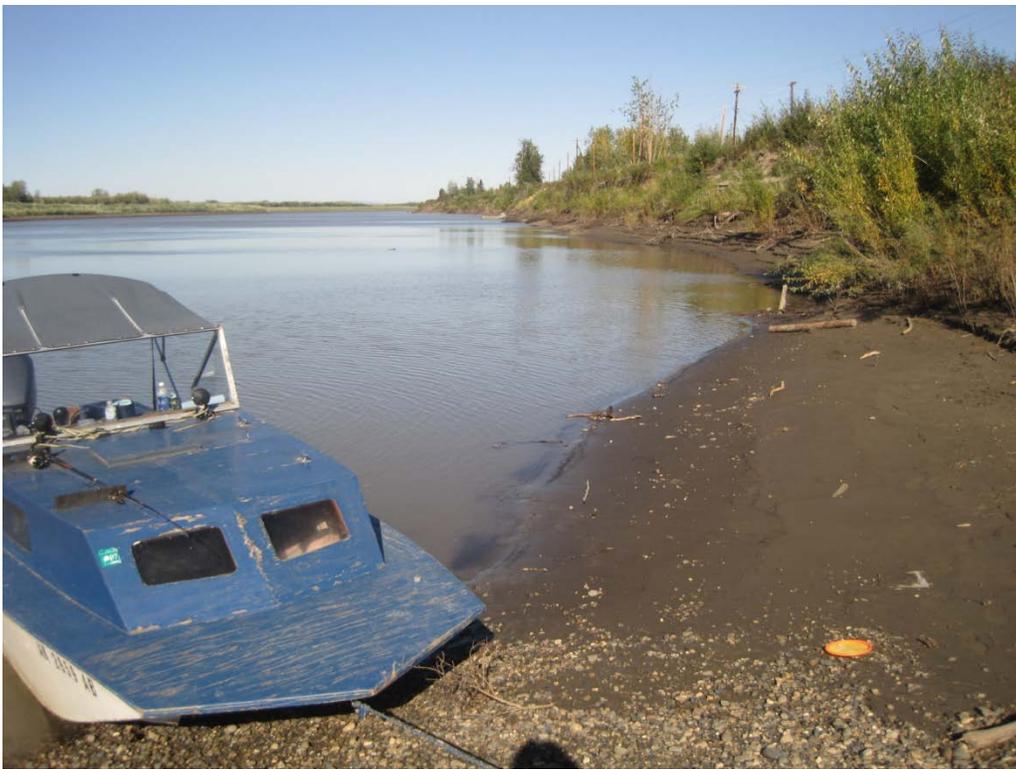
Photo 17. Looking downstream from power plant landing ramp
