Memorandum for Record

Subject: Inspection of Wainwright Lagoon Boat Launch

Wainwright Lagoon Boat Launch - Inspection

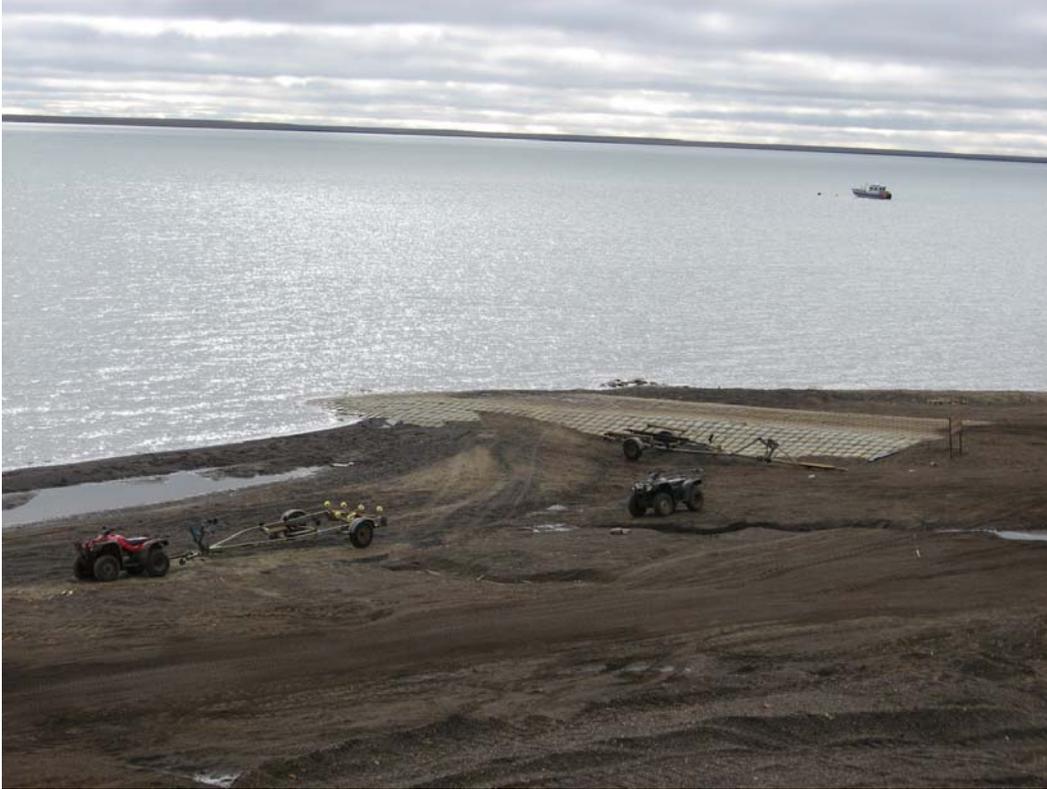
Photo 1: General view of boat launch ramp looking south-southwest.

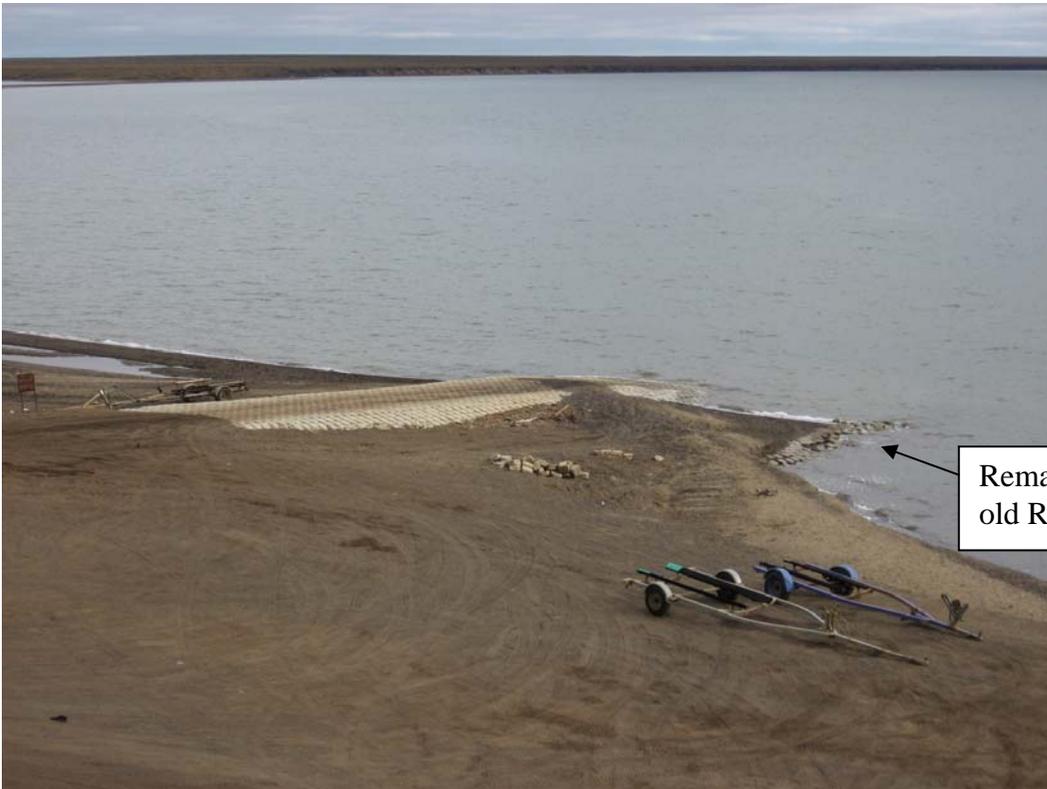
The scope of this project was to replace the deteriorated existing launch ramp that existed at virtually the same site, see Photo 3. Mayor Oktollik placed the construction of the old launch ramp in the 1980's. The construction of this replacement project was originally completed in the fall of 2009; however the launch ramp was placed too high on the shoreline and did not extend far enough into the waters of Wainwright Lagoon. The project was reconstructed during the spring/summer of 2010. I did not find any issues that relate to or are a result of the reconstruction of this project.

Photo 2: New launch ramp and adjacent remains of old ramp.

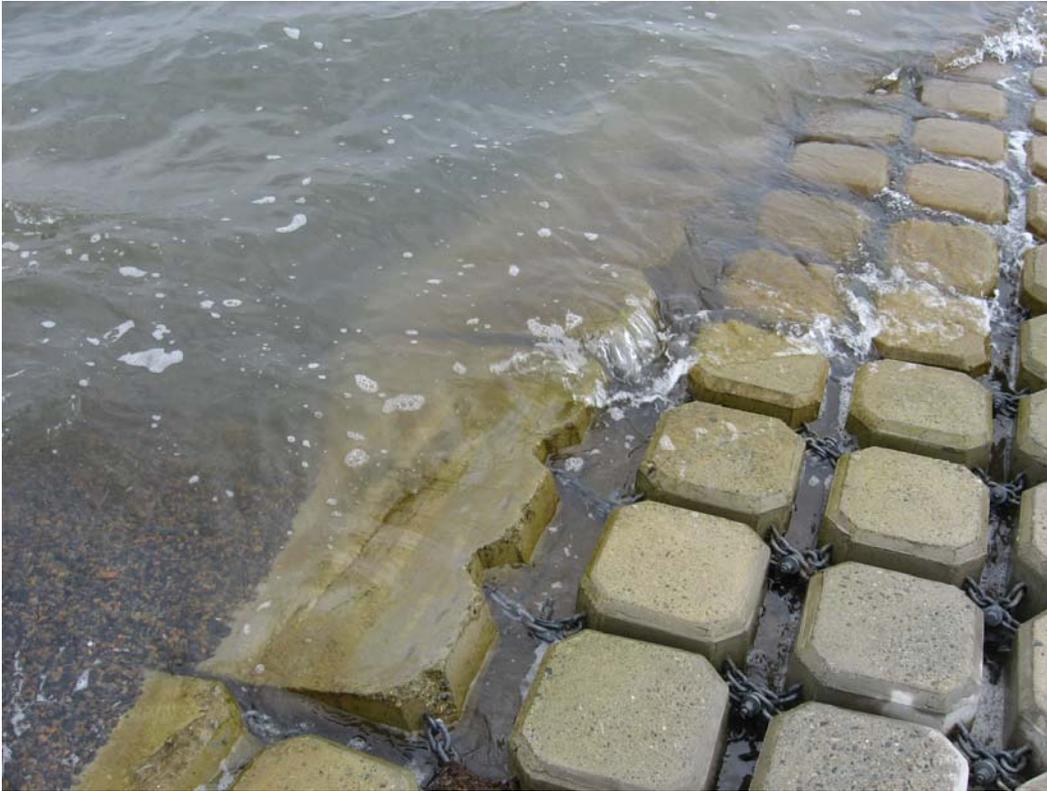
launch ramp that was being replaced. The primary difference being that chains and bolts (see Photo 3) are used in the new construction rather than cables and cable clamps (see Photo 4) to secure the precast concrete ramp blocks. Construction and condition of all major elements of the project were deemed to be sound. The following deficiencies were noted:

Photo 3: General view of launch ramp construction – note chains & bolts.

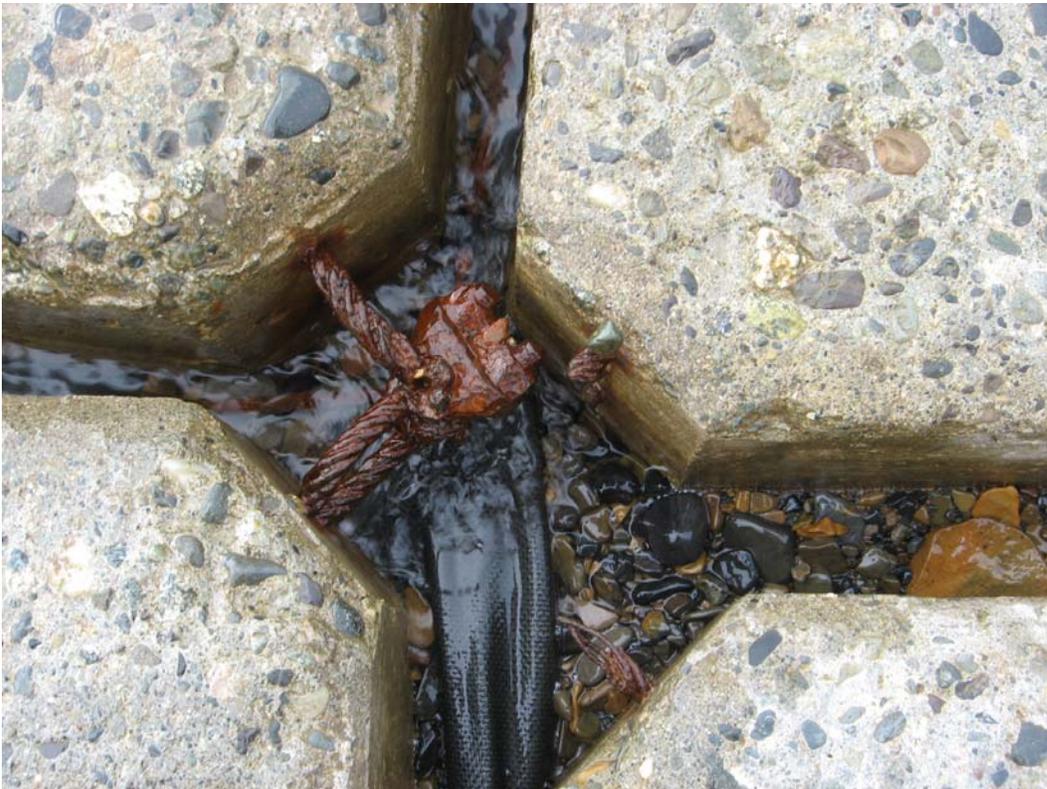
Photo 4: Corroded connecting cables with clamp in old ramp construction.

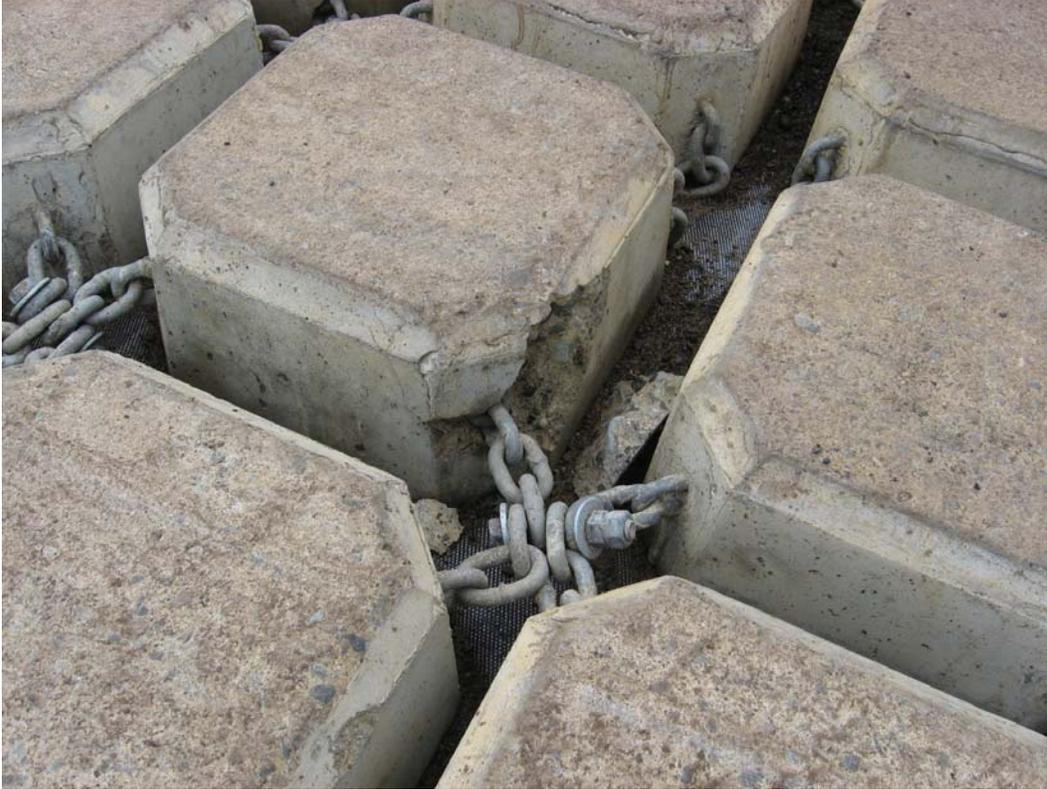
a. Bolt missing at one precast concrete block connection:

At one location in the launch ramp the connecting chains were not fastened together, see Photo 5. These connections are the key in allowing the mat of individual concrete blocks to act as a unit. The presence of spalling at an adjacent connection as well as a bent connecting bolt may be an indication of excessive “tightness” of the connecting chains in this vicinity. (I do not consider the bolt being bent to be a detriment to the performance of the system.) Recommend that the missing connection be repaired. The repair should accomplish a relatively tight connection in all four affected chains. A slightly longer repair link could be substituted for one of the end links in the connection and allow proper fit-up.

Photo 5: Missing connection bolt and spalled adjacent connection with bent bolt.

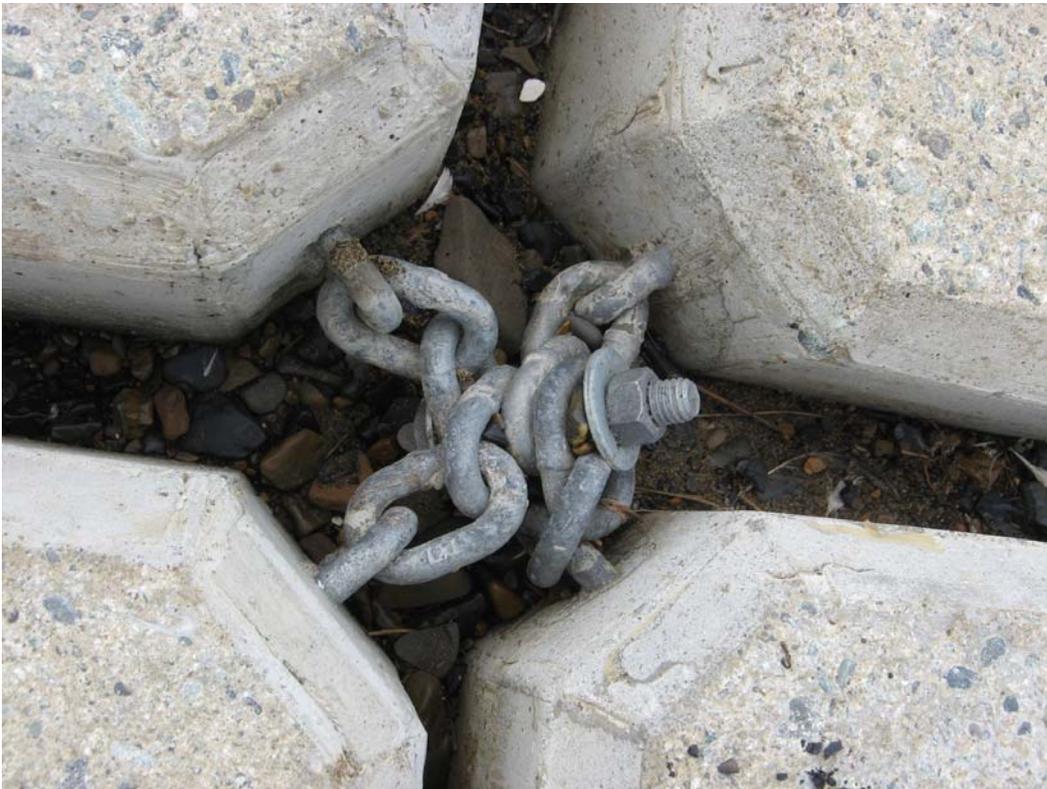
b. Missing double nuts on connecting bolts:

During my inspection looked at all of the connecting bolts and I counted approximately ten bolted connections where the specified double nut was not present, see Photo 6. Recommend that all connections receive a double nut as specified. In most instances this merely requires installing and tightening the additional nut against the existing nut. At some locations a longer bolt may be needed as the available chain length may not be sufficient to tighten the connection enough to provide the extra threads for the second nut. In a few of the locations without a double nut, a nut was found adjacent to the connection, lying on the filter fabric. Please see the following comment regarding loose double nuts.

Photo 6: Connecting bolt without specified double nut.

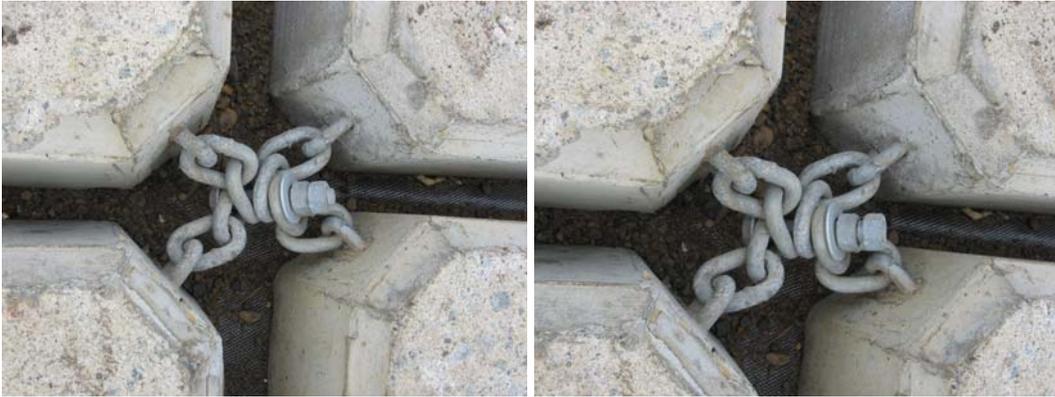
c. Loose second nut at double nut connections:

I found that some of the second nuts in the double nut connections were loose enough to be removed by hand (see Photo 7). The looseness of some of the double nuts and the presence of some “extra” nuts adjacent to missing double nuts suggests that some of the loose double nuts have been coming off. I recommend that all connections be checked and all loose connections be tightened.

Photo 7 : Double nut connection before and after loosening second nut by hand.

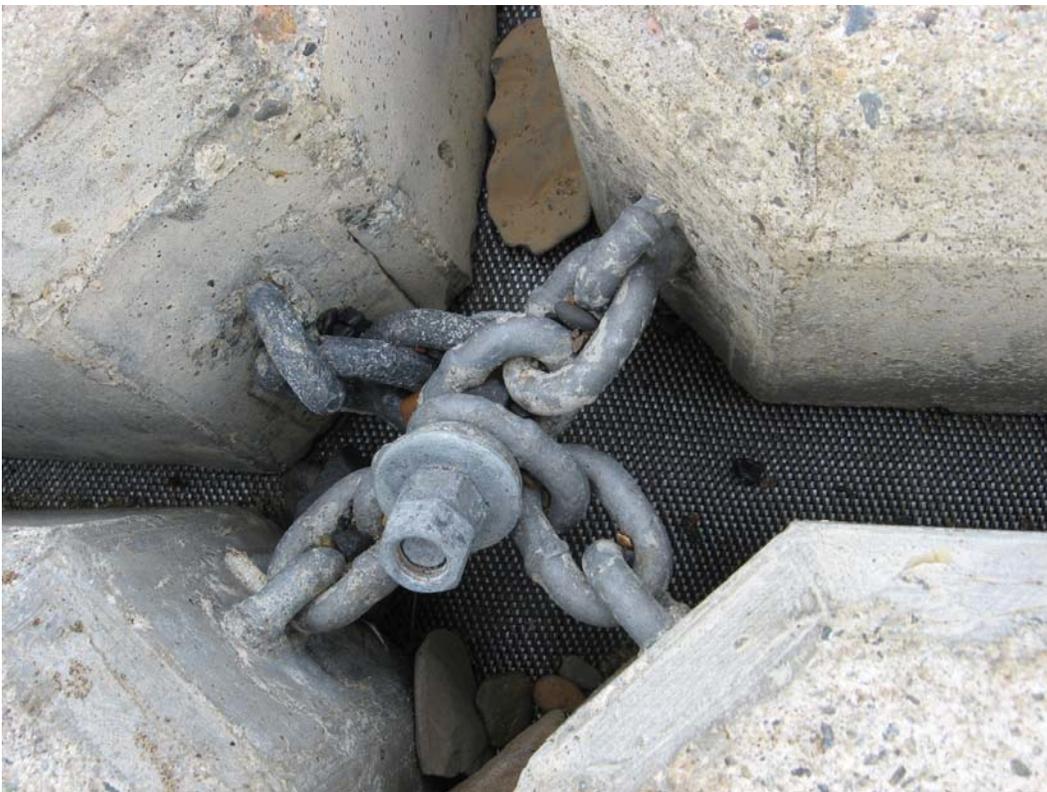
d. Double nut not fully engaged in bolt threads:

In several locations I found that the length of available threads was insufficient to allow the double nut to be fully threaded onto the bolt (see Photo 8). Without tools I was unable to determine if this was caused by too short of bolt, or just that the first nut was not run down enough on the bolt. I suspect that longer bolts may be required to correct this in most locations. This is a minor issue, but I recommend that all double nuts be installed with at least half of their threads engaged. This is based on

the assumption that a half-nut, or jamb nut, would have sufficed to lock the connection. The resulting “cup” will hold water and accelerate corrosion. Use of a jamb nut would be a better solution in lieu of providing a longer bolt.

Photo 8: Double nut not fully engaged with bolt threads.

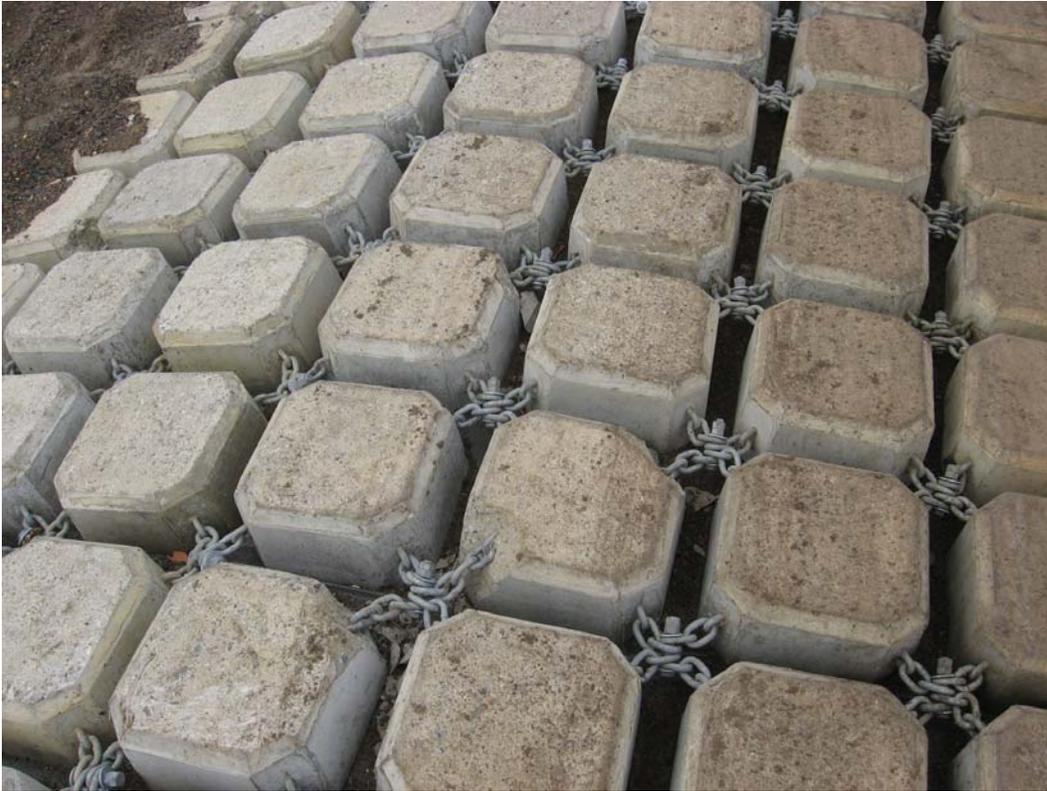
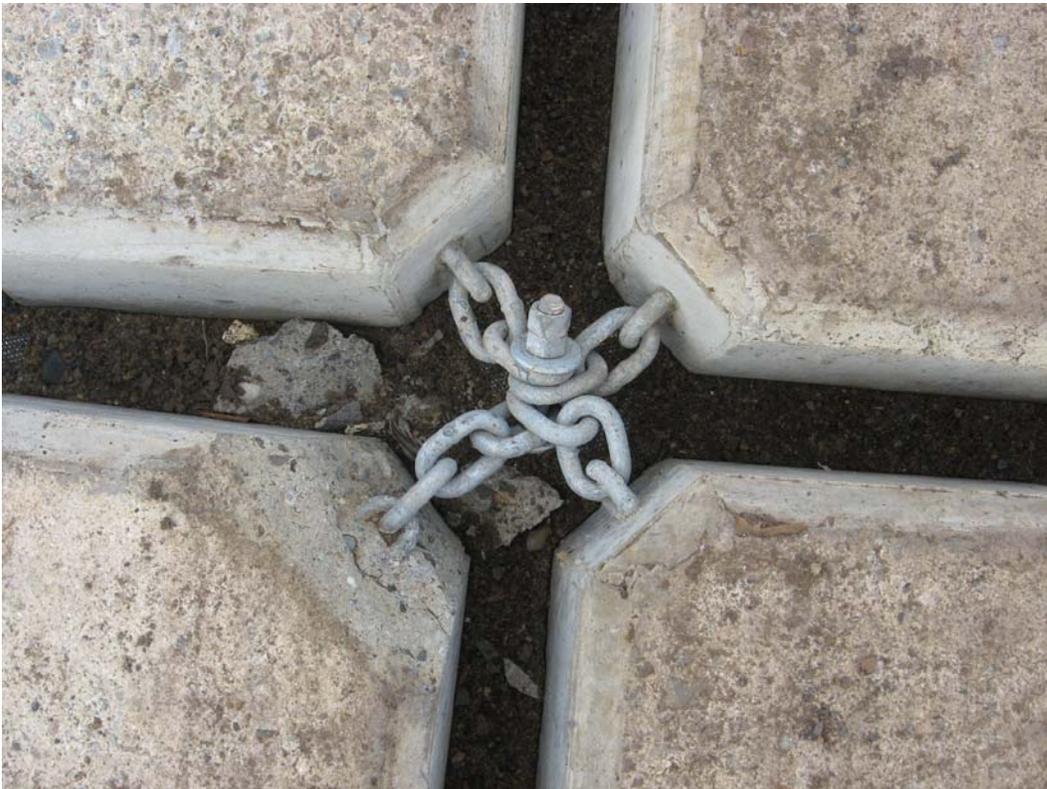
e. Spalled concrete corners on precast blocks:

During my inspection I noted that several of the precast concrete blocks have spalled corners where the connecting chains come out of the blocks (see Photo 9 and Photo 10). As the ramp has been in service for some time, I could not determine if this is normal wear-and-tear, or if this was the condition when the ramp was completed. This condition should be monitored, and if these blocks continue to deteriorate more rapidly than the remainder of the blocks, then replacement should be considered.

Photo 9: Several spalled corners on precast concrete blocks.

Photo 10: Close-up of spalled corner showing crack in concrete.

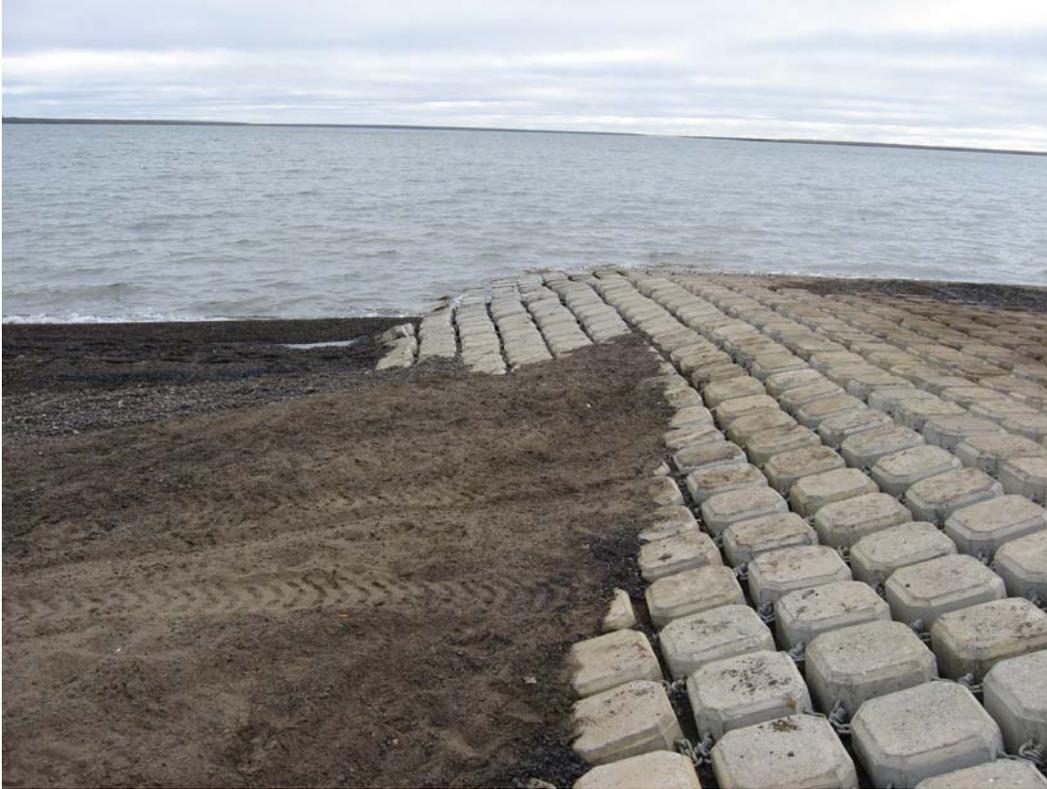
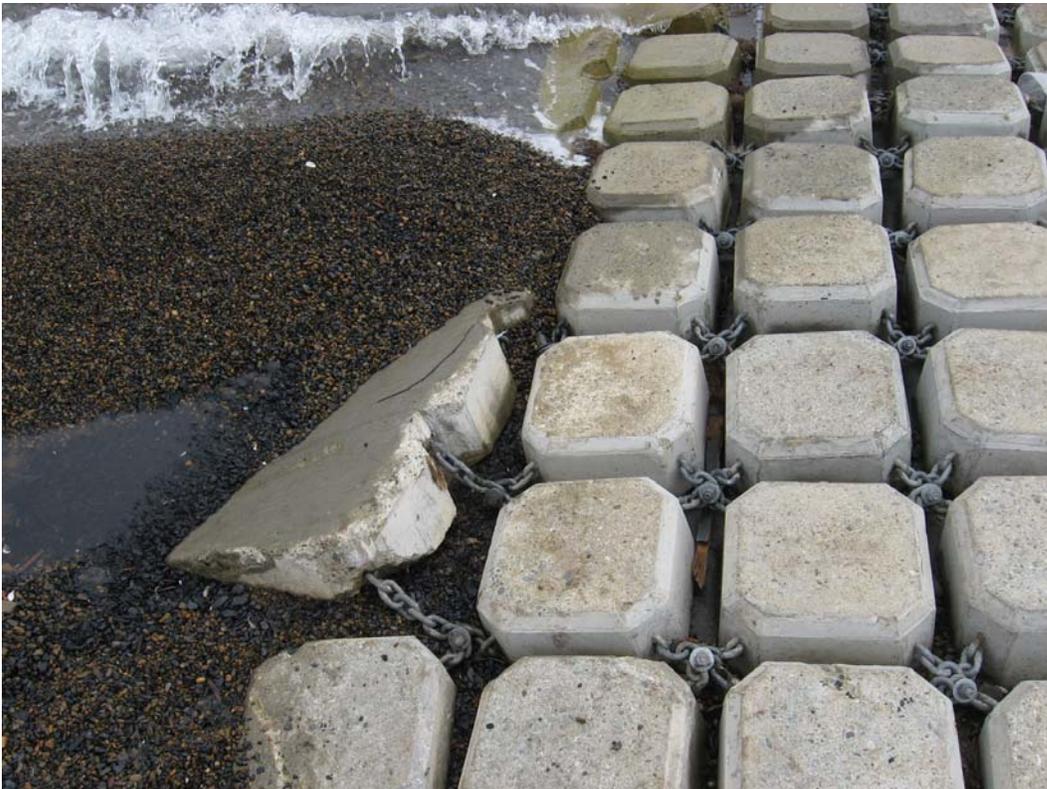
a. Displaced anchor block near water’s edge on northeast side:

One of the precast concrete anchor blocks along the edges of the ramp was noted to be displaced (see Photo 11 and Photo 12). Recommend that this anchor block be repositioned to its originally required position.

Photo 11: Displaced anchor block near water's edge.

Photo 12: Close-up of displaced anchor block.

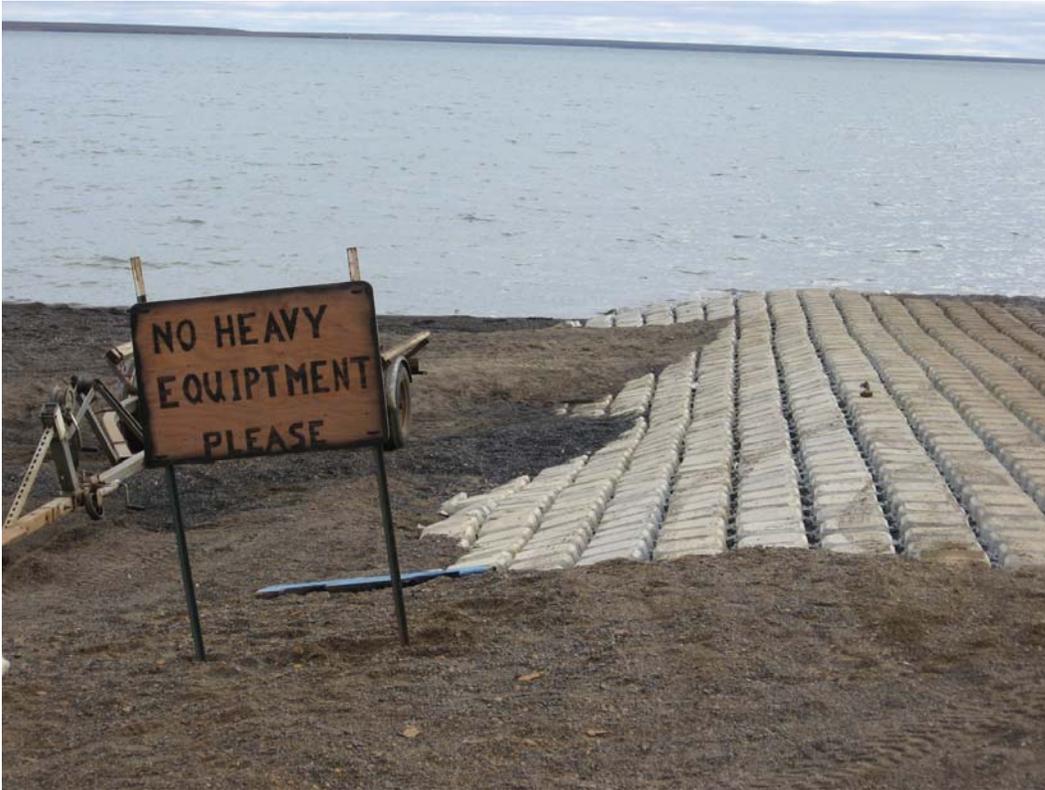
b. Restriction on ramp use by heavy equipment:

It is appropriate to restrict the use of the ramp and a temporary sign has been provided (see Photo 13). Recommend that a permanent sign be provided and installed.

Photo 13: Temporary sign prohibiting use by heavy equipment.
