Trip Report
Seldovia Harbor Improvements
September 10, 2009

This trip report documents the site visit to Seldovia, Alaska to investigate harbor improvements as part of the AKV292 (326049) Seldovia Harbor Improvements Denali Commission project.

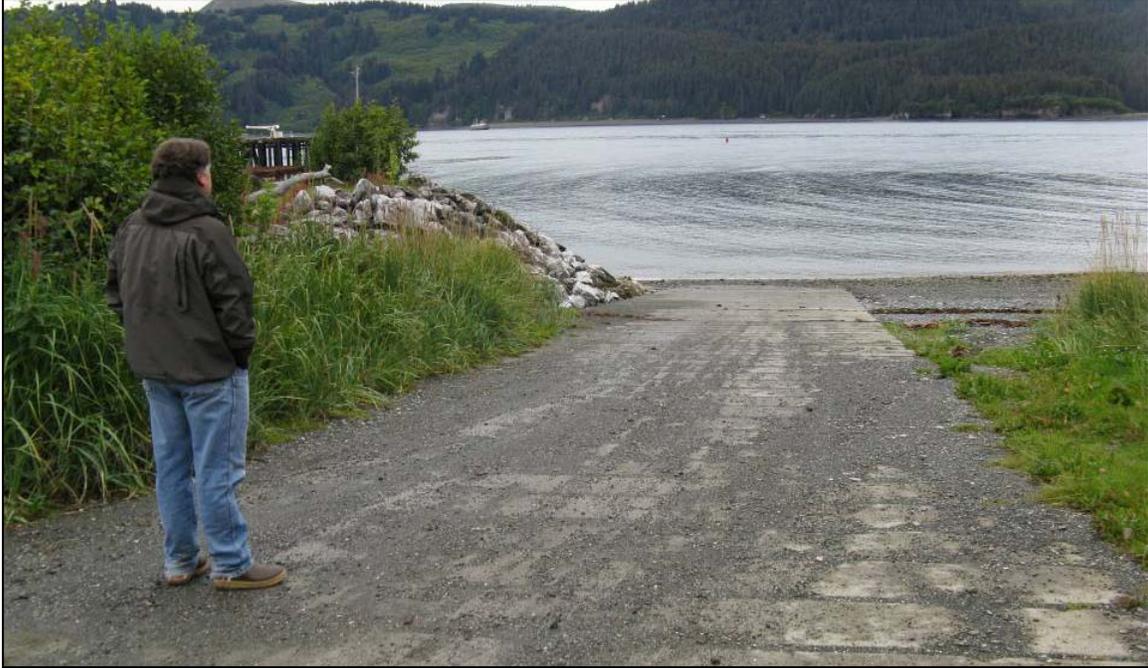
The community boat launch facilities appear to be in satisfactory condition with the city reporting no issues. There are two launches. The large vessel launch is to the north of the harbor and the City dock. The city operates a tractor and trailer to haul larger vessels out of the water. The inner harbor boat launch is at the northern end of the boat harbor. This launch is available for regular trailered boat launching and recovery. Neither launch facility has a dock.

Figure 13 – Large Vessel Launch

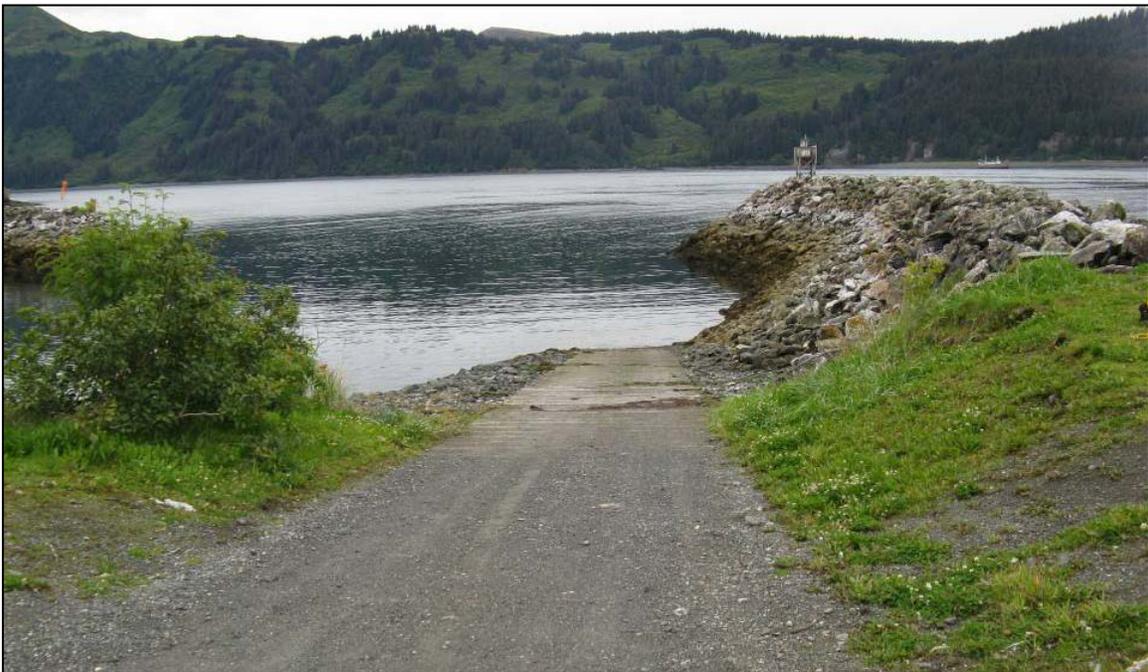
Figure 14 - Inner Harbor Boat Launch
