# ALASKA DISTRICT TRIP REPORT

**Project:** Denali Commission Mooring Points Phase 4

**Description:** Stevens Village Trip Report

**Date:** 19 August 2011

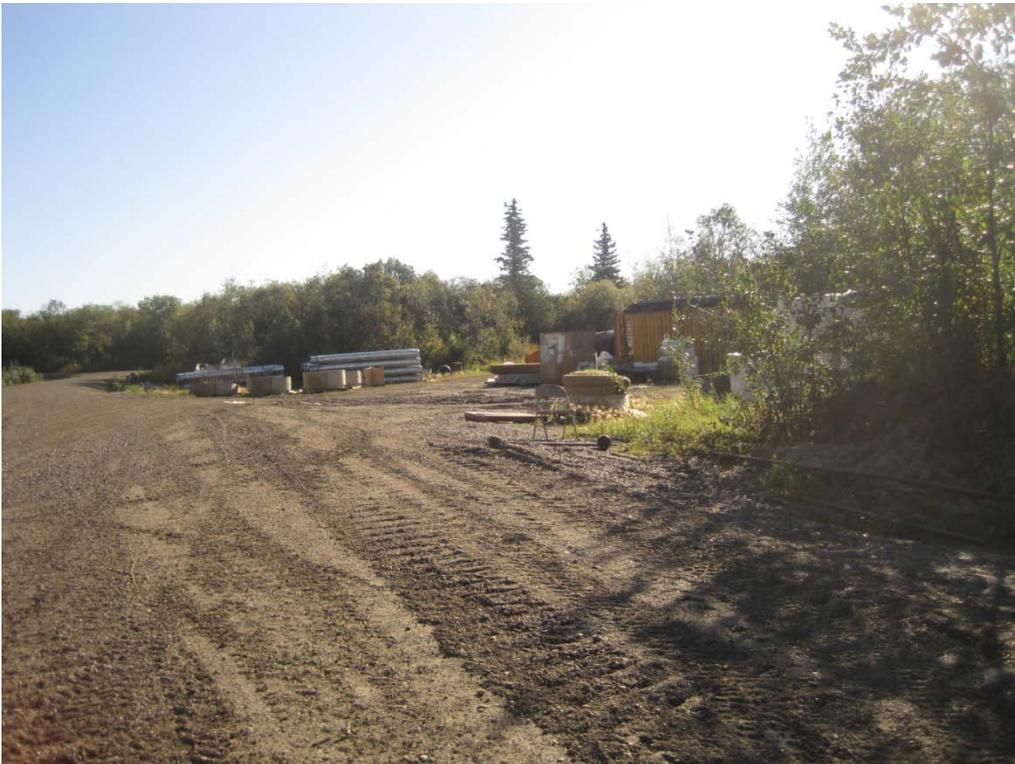
Photo 2. Freight landing staging area

This landing consists of a gravel ramp perpendicular to the river (Photo 1) with a staging area on the upstream side of the access road to the ramp (Photo 2). Materials for a road construction project were stored at the staging area during the time of our visit. Two boats were beached above the water at this site during our visit.
