DISTRICT TRIP REPORT

Project: Denali Commission Moorings Points Phase 3 – Kuskokwim River

Description: Napaskiak Trip Report

Date: 23 September 2010

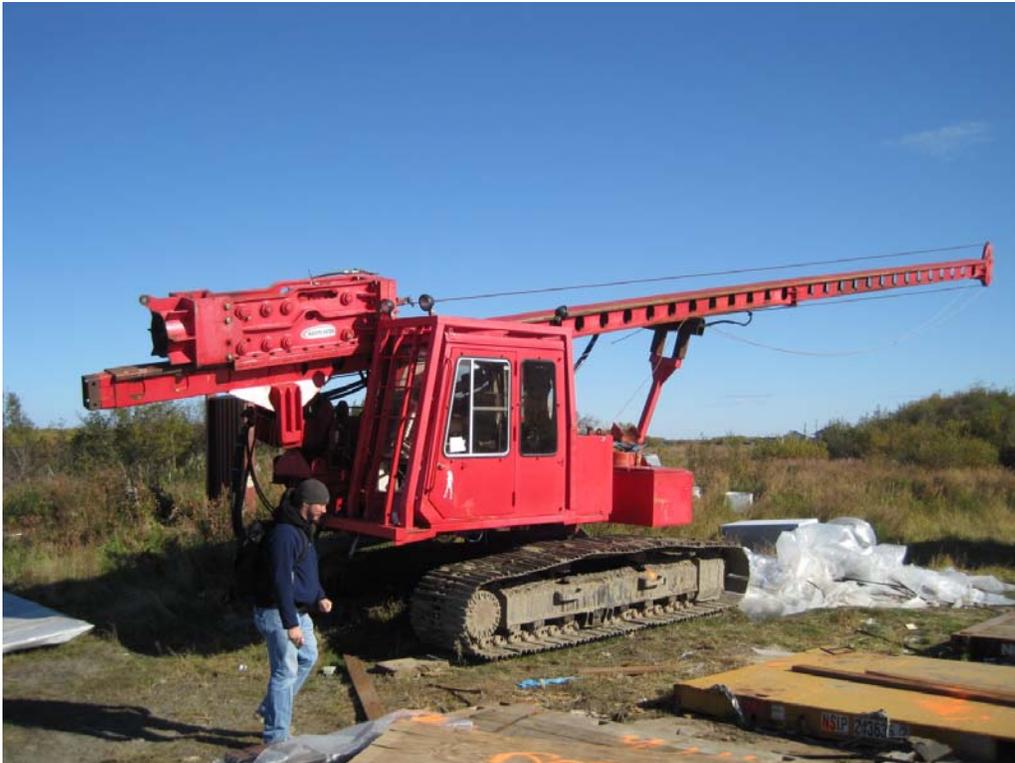
What appeared to be a pile driver was being stored at the landing area during our site visit (Photo 1). Either the local Native Corporation or the Napaskiak Utility Company would know the status of this equipment.

Photo 1: Pile Driver at Freight Landing Staging Area

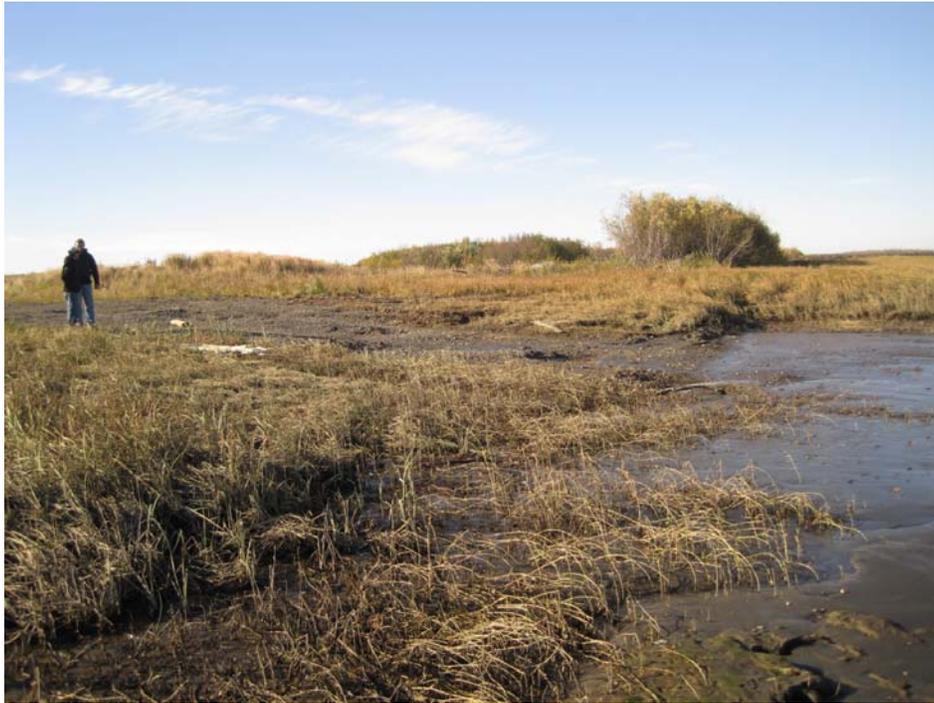
The landing area is a shallow mud and gravel slope accessing the Napaskiak Slough just upstream of its confluence with the Kuskokwim River near the northeastern end of the airstrip (Photo 2). Tall grasses cover flat river banks both up and downstream from the ramp. There is a line of trees approximately 70 feet back from the high tide line. Beyond this is located a staging area.

Photo 2: Freight Barge Landing Area Looking West

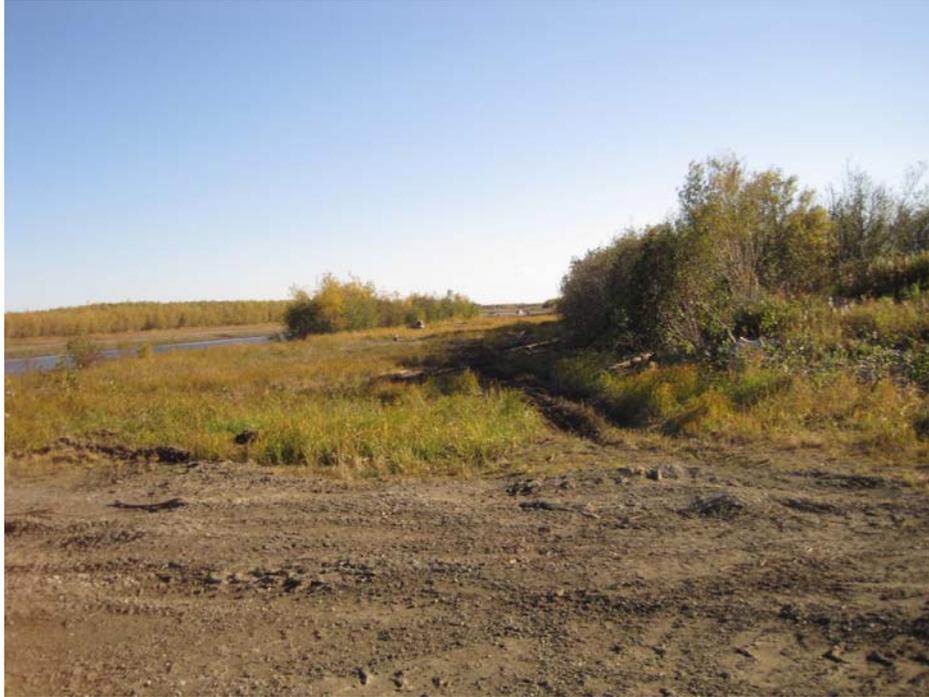
Photo 3: Freight Barge Landing Area Looking East. One Mooring Point Could be Placed at Edge of Line of Trees

Placement of any mooring points at this site should be in the vicinity of the line of trees approximately 70 feet back from the high tide line (Photo 3). If placed close to the trees they

will pose less of a safety hazard and could be above grade installations. From the east the trees are directly adjacent to the access road to the landing site. To the west of the access road, the trees don't begin for 160 feet (Photo 4). Above grade mooring points placed at these two locations where the line of trees start would adequately serve barges that come in nose first to the site.

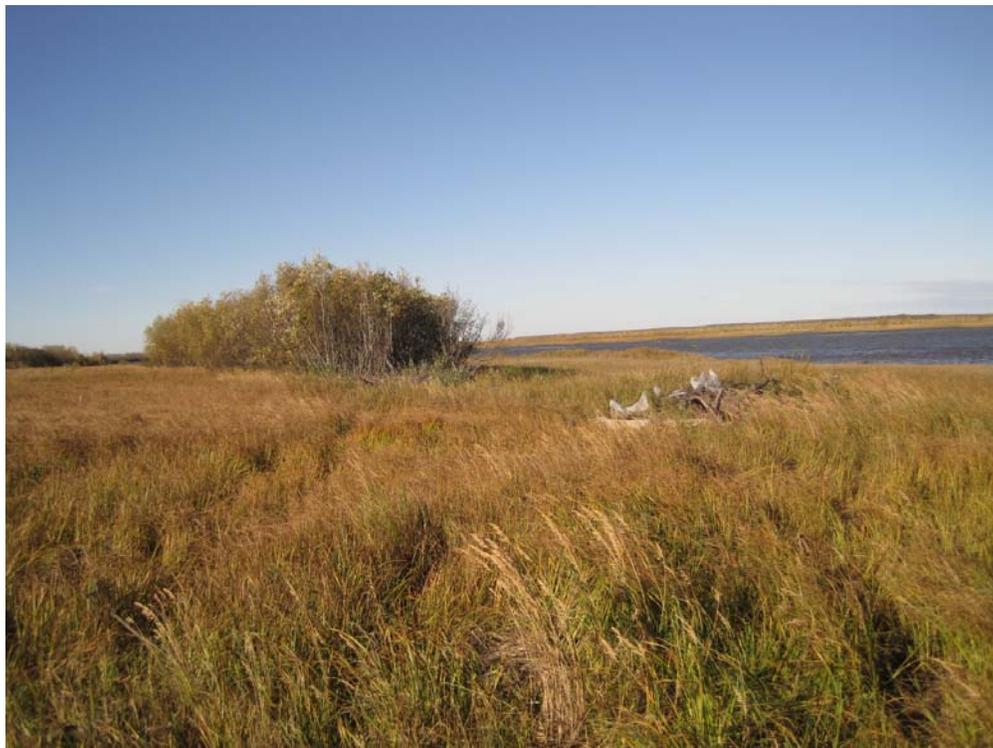
Photo 4: Freight Barge Landing Area Looking West. One Mooring Point Could be Placed at the Near Edge of the Line of Trees.

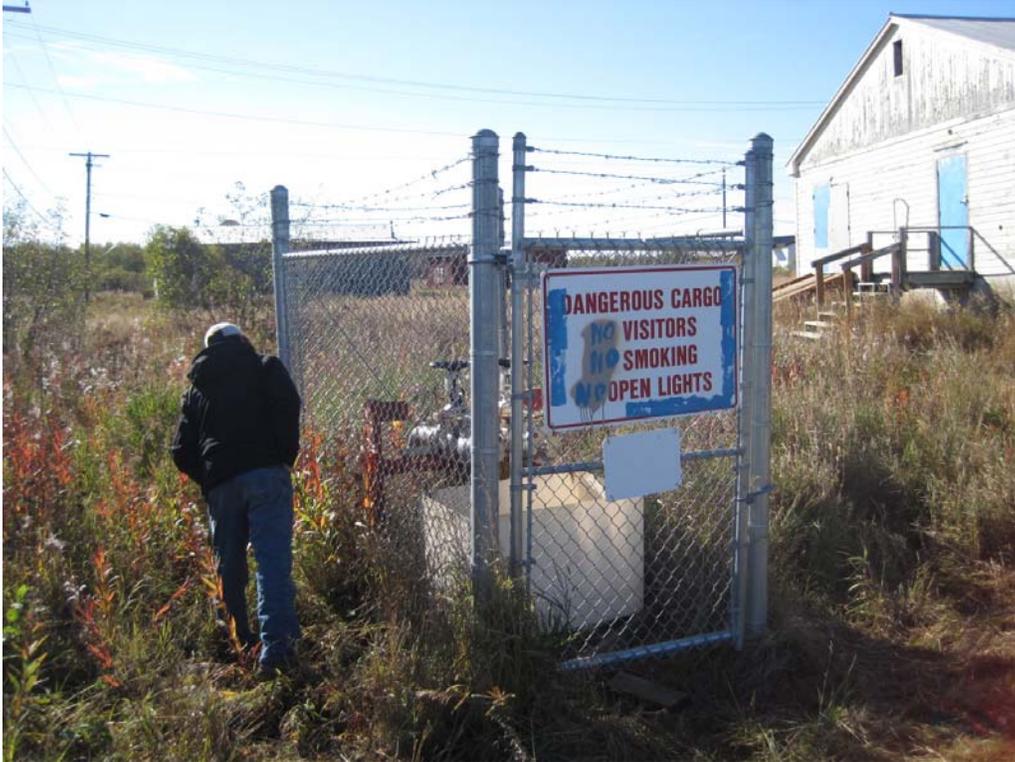
The fuel header is located across the main boardwalk from the slough and to the west of the school (Photo 5).

Photo 5: Fuel Header

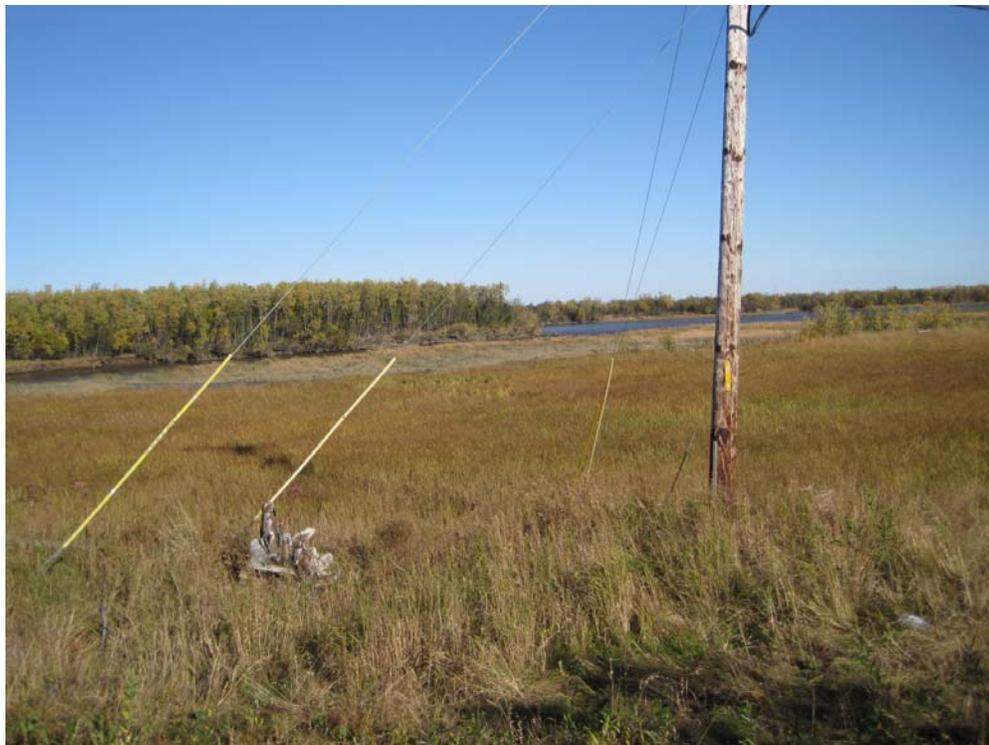
The fuel barge landing site is located in Napaskiak Slough to the east of the freight landing area and nearly directly north of the school. It is labeled on Figure E25 of the barge landing report as “old landing area.” A smaller slough, which only is submerged during higher tides, must be crossed to access the site from the village (Photo 6).

Photo 6: View of Fuel Landing Site from Fuel Header

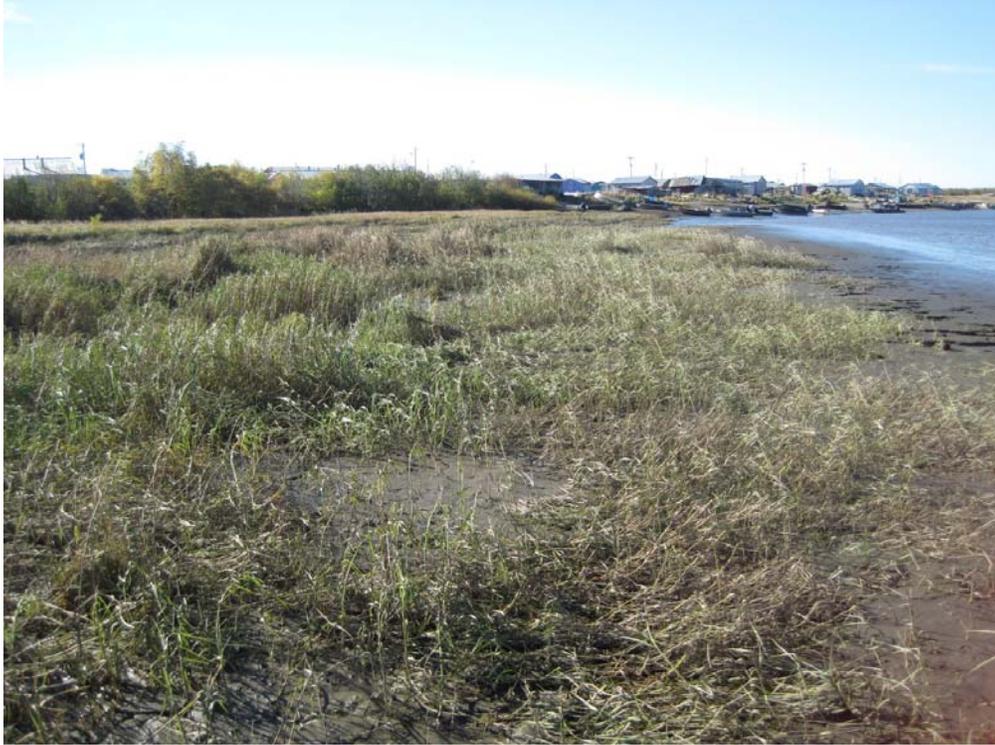
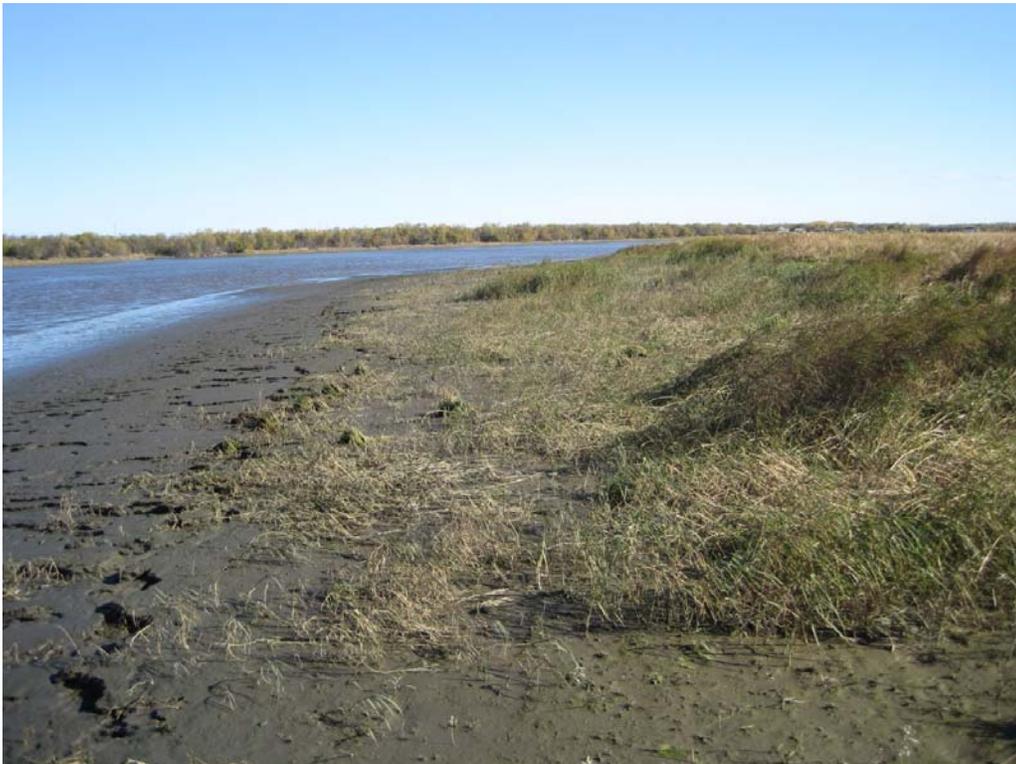
The area indicated as the landing site was extremely flat and muddy with no current. There were no landmarks to base placement of the mooring points upon, just swamp vegetation (Photos 7 – 8). There was no obvious indication of where past barges had come in to access the site.

Photo 7: Looking West from Fuel Barge Landing Site

Photo 8: Looking East from Fuel Barge Landing Site

Since this site is wide open and along a slough, it is likely a high traffic area, especially in winter. From a safety perspective, below grade mooring points are preferred, however, they would be difficult to locate due to the lack of landmarks and wet and muddy terrain prevalent in the vicinity.

Due to the prevalent shallow depths and proximity to Bethel, Crowley utilizes a skiff sized vessel to deliver fuel to Napaskiak. Mooring points would not greatly improve the efficiency of fuel offloading operations at this site, hence installation of mooring points is not recommended.

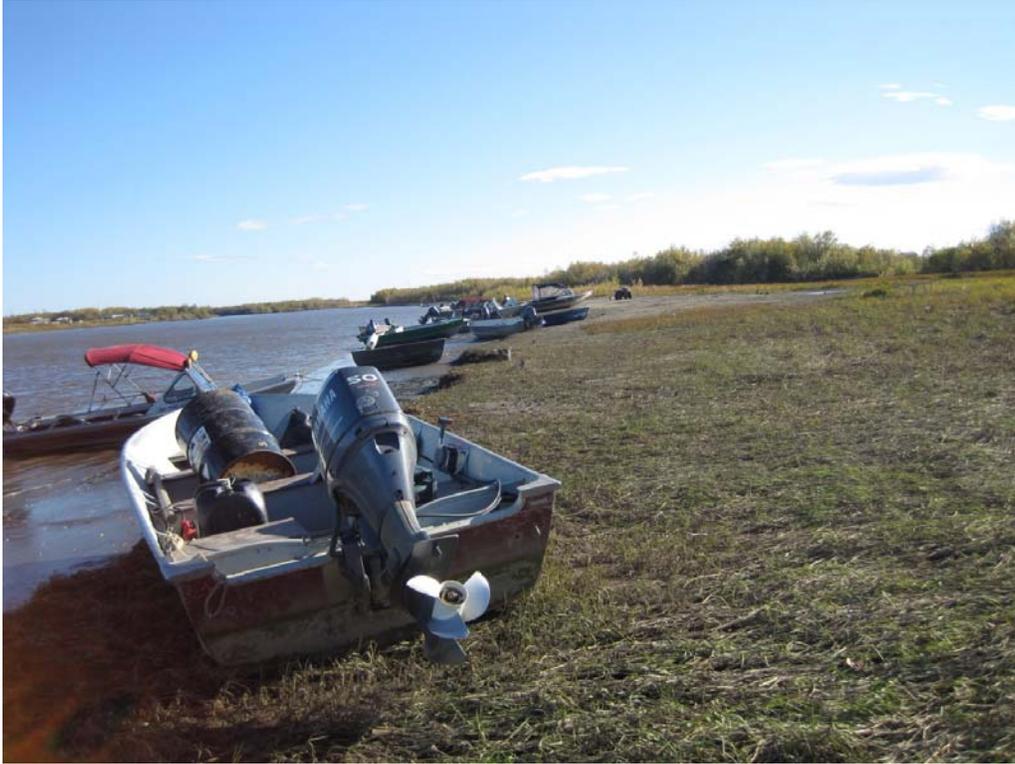
There is an obvious landing area located about 600 feet east of the indicated fuel landing site. There were many skiffs beached here (Photo 9). There was a slightly pot-holed and muddy staging area inland from the landing area. It appeared that this site could be a better alternative to the fuel landing site we were shown.

Photo 9: Barge Landing Site Located East of Fuel Barge Landing Site

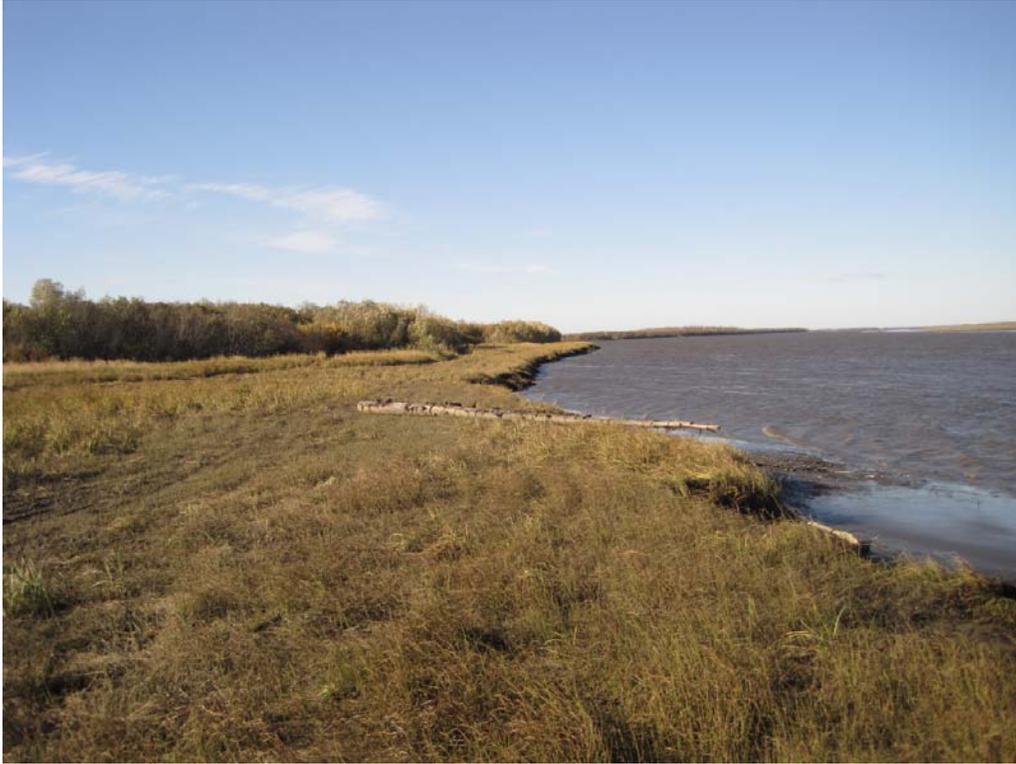
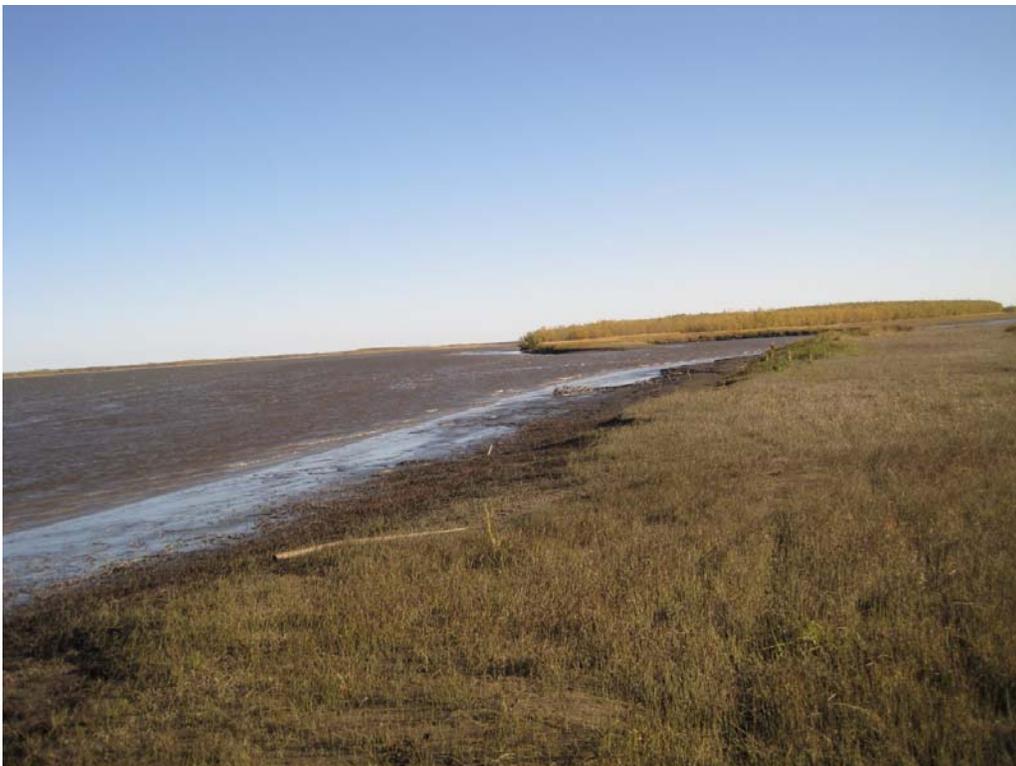
The hovercraft landing area is a broad, flat, muddy landing with no obvious particular landing spot – there is just a muddy road leading to the river bank that indicates where the hovercraft likely comes in (Photos 10 – 11). It is located on the mainstem of the Kuskokwim River west of the northeastern end of the airstrip.

This site actually has deeper water than the freight landing site but it lacks a suitable upland site to stage and store equipment and freight. With development of an improved landing/staging area, this site could possibly be an improvement upon the existing freight barge landing area.

Photo 10: Looking South from Hovercraft Landing Site

Photo 11: Looking North from Hovercraft Landing Area
